APPENDIX B
PHOTOGRAPHS

Photo B-1: Overall view of Pier 40, looking southeast.

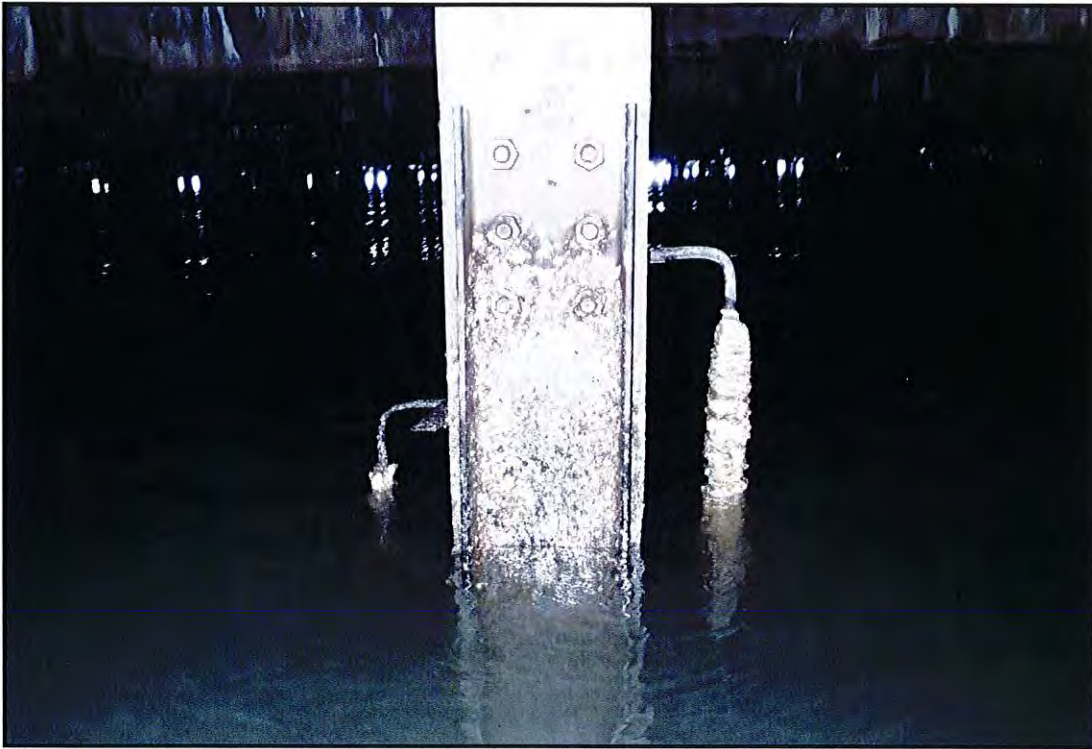
Photo B-11: Typical C-channel pile repair bolted to the flanges of H-pile I-bar 9-bar, view looking west. Note the depleted anodes attached to each side of the H-pile.

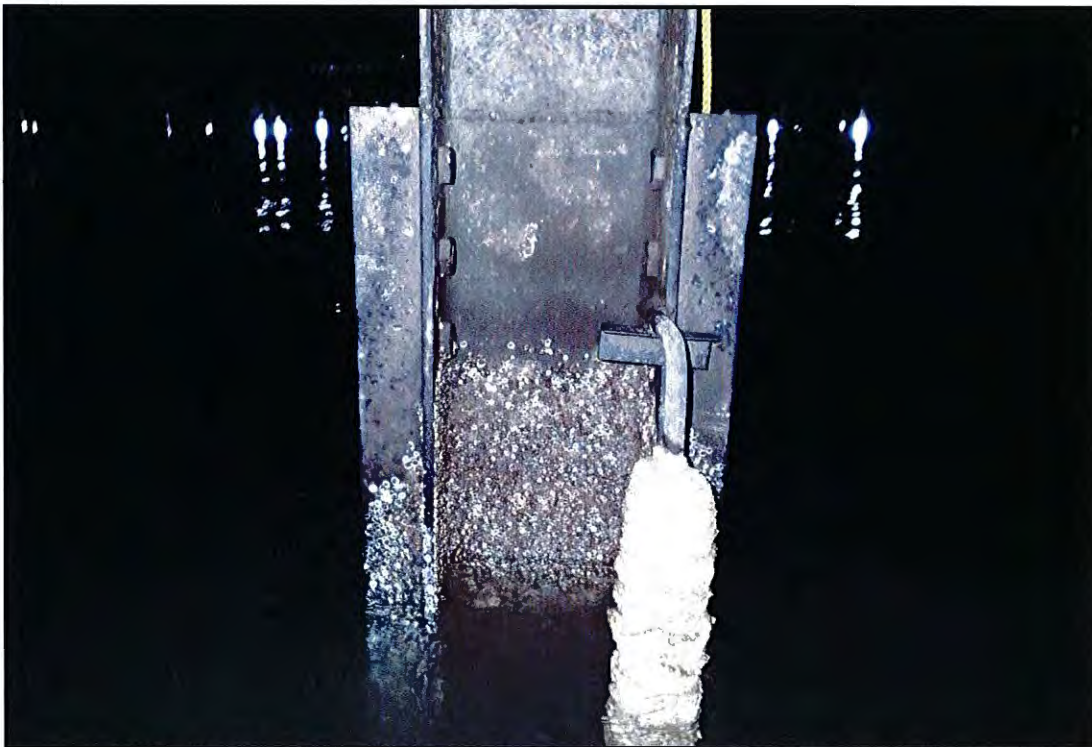
Photo B-12: Typical C-channel pile repair bolted to the flanges of H-pile I-bar 9-bar, view looking south.

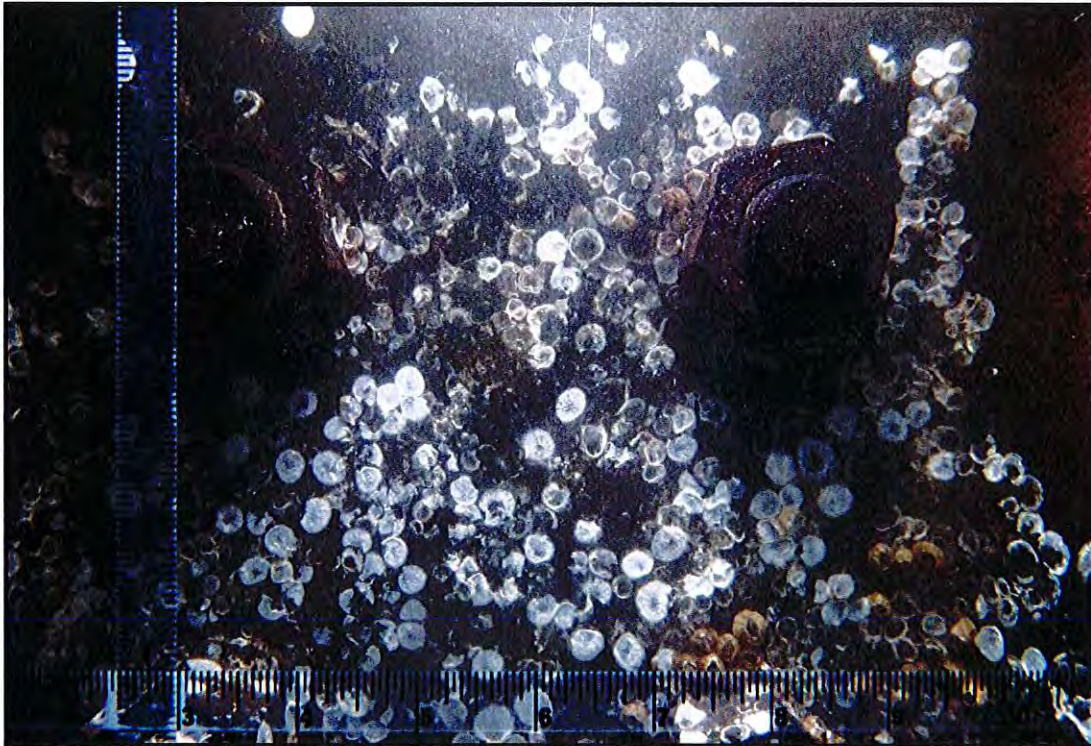
Photo B-13: Typical condition of bolts at the C-channel repairs. Photo at H-pile location T 18.75 in the Pier Shed.

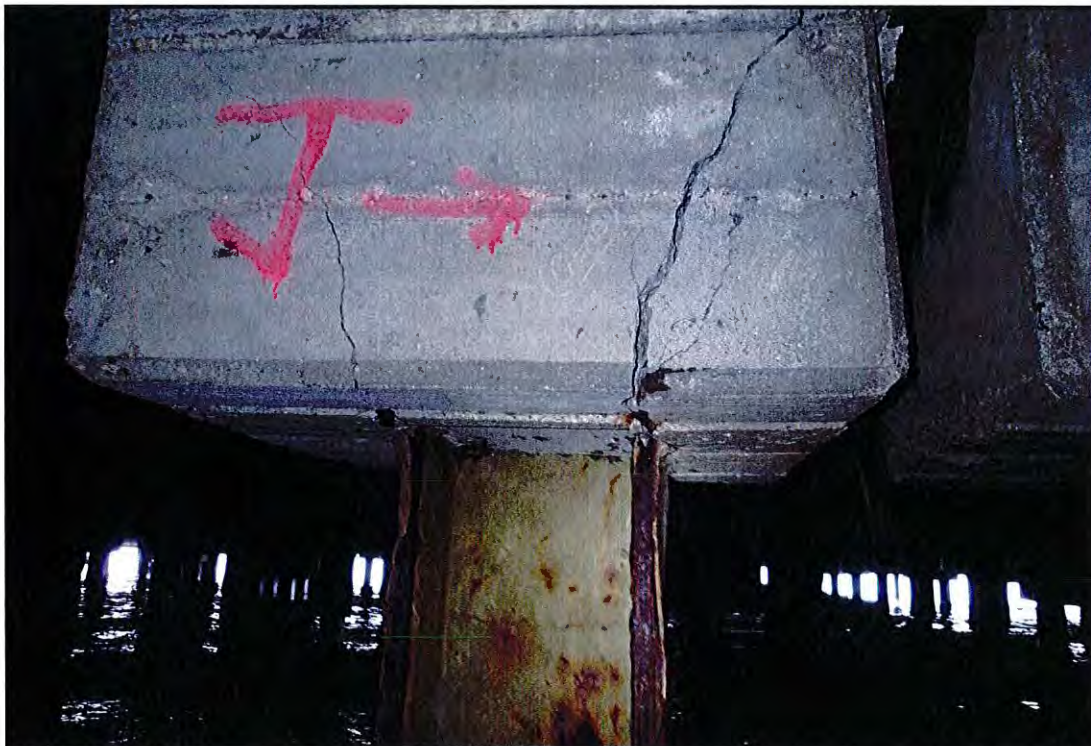
Photo B-14: Typical rust staining and delamination of epoxy coating at Bent Q.25, Pile Row 16S. Note, corrosion of the H-pile flange has caused a large crack in the concrete pile cap.

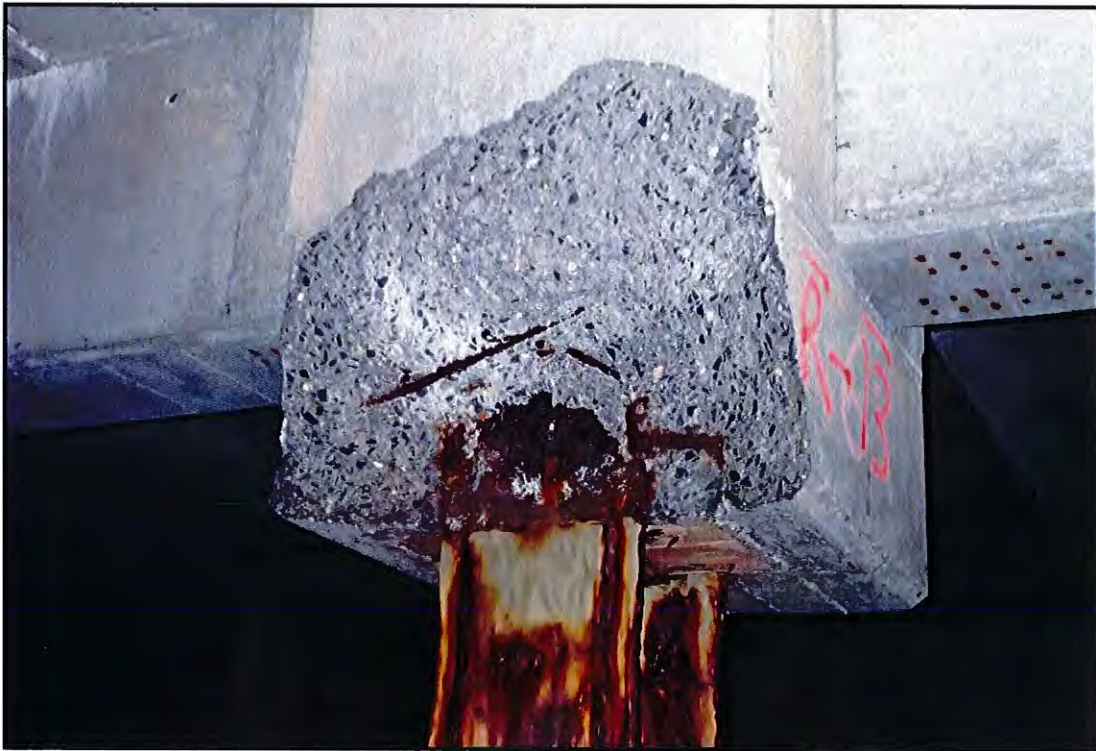
Photo B-15: Typical rust staining and delamination of epoxy coating at Bent R.75, Pile Row 13-bar. Note, corrosion of the flange has caused a large spall in the concrete pile cap.

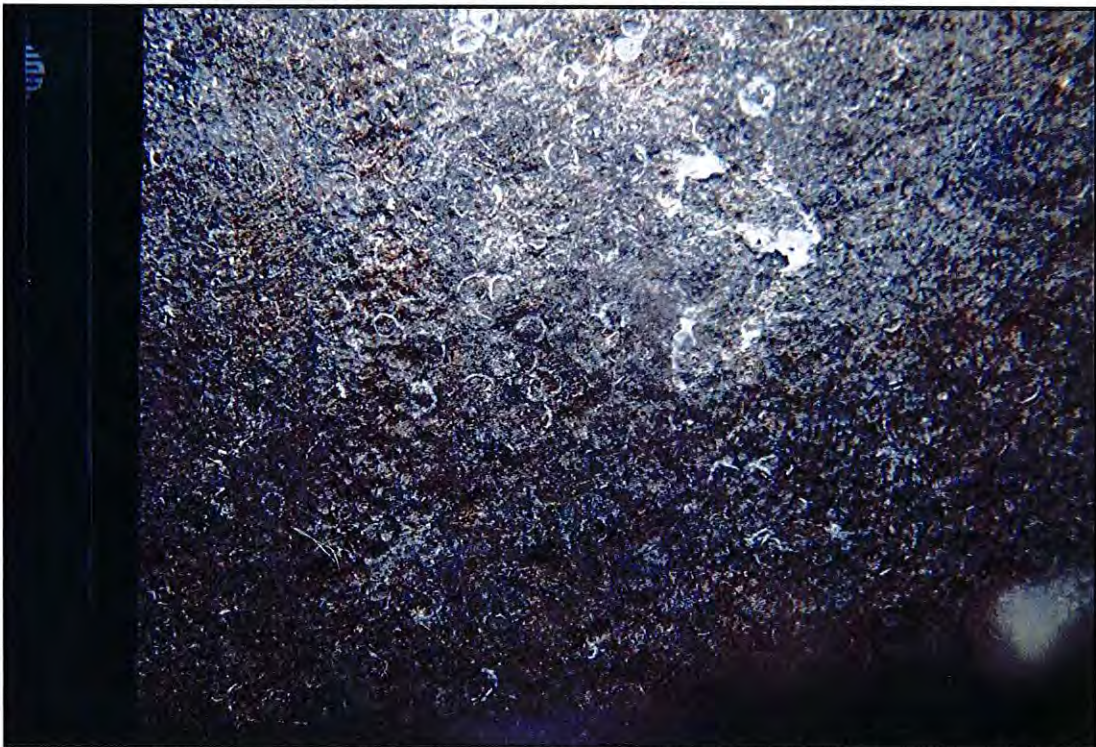
Photo B-16: Typical condition of the flange of a H-pile graded Minor. H-pile location at Bent S-bar and Pile Row 19.

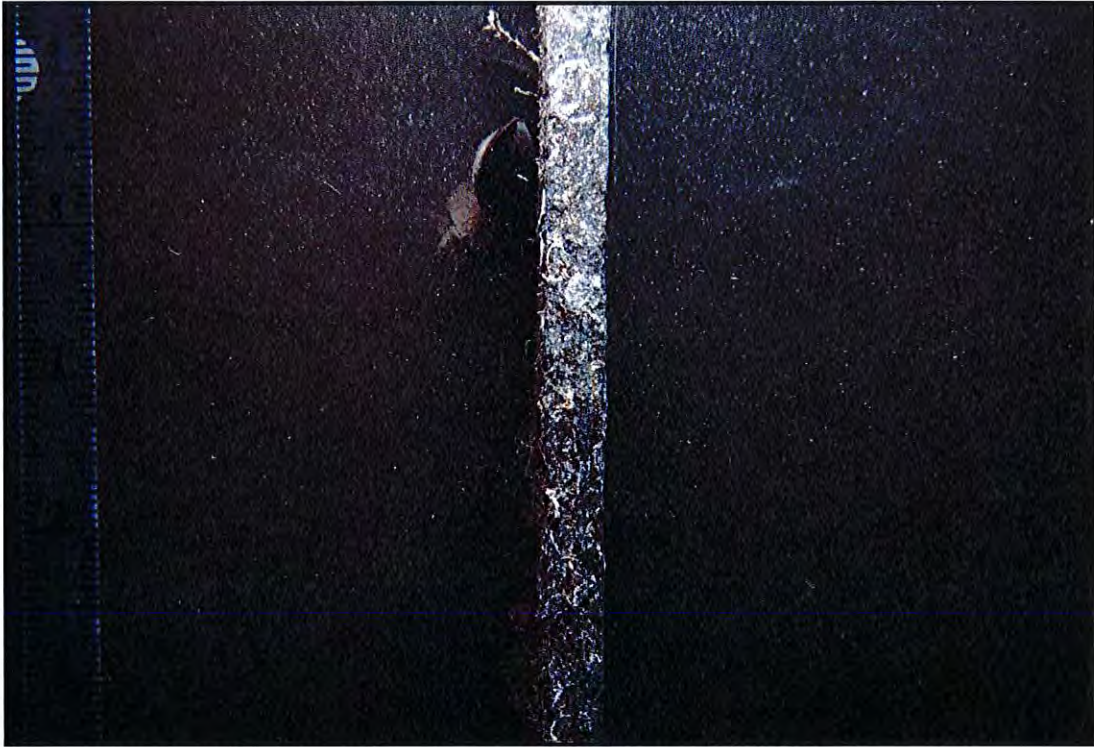
Photo B-17: Typical condition of the flange edge of a H-pile graded Minor. H-pile location at Bent S-bar and Pile Row 19.

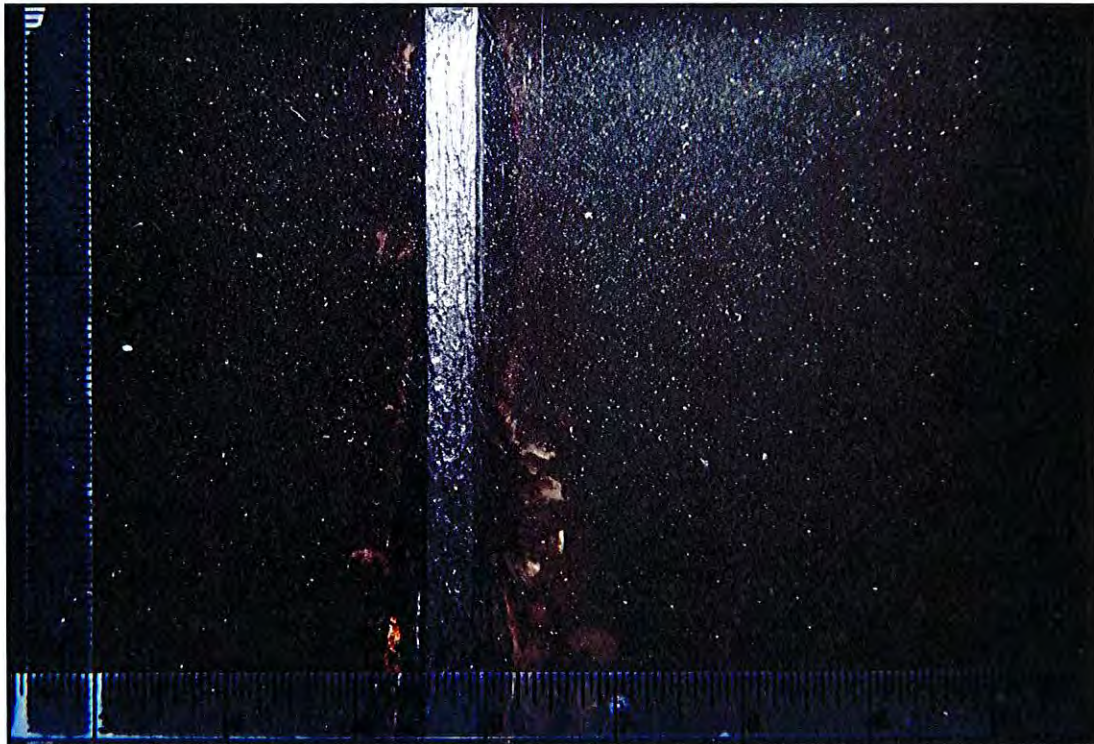
Photo B-18: Typical condition of the flange edge of a H-pile graded Moderate. H-pile location at Bent T and Pile Row 21.

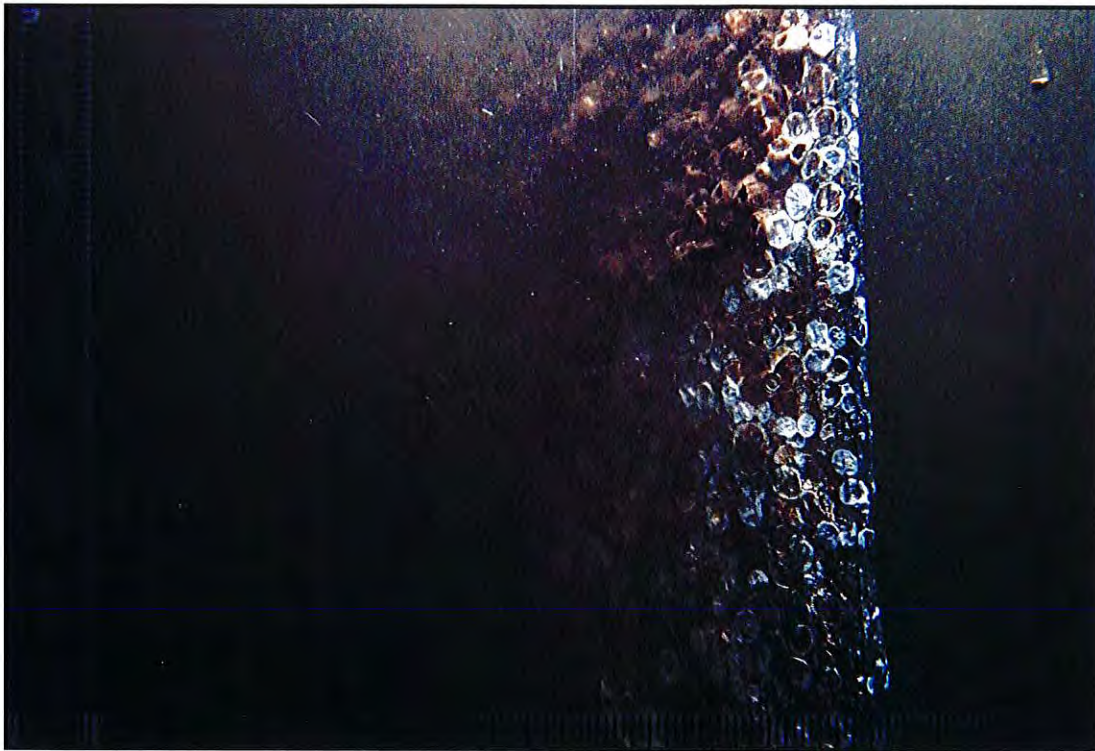
Photo B-19: Typical condition of the flange edge and flange face of a H-pile graded Major. H-pile location is the center-west H-pile of the pile cluster at Bent L and Pile Row 19.

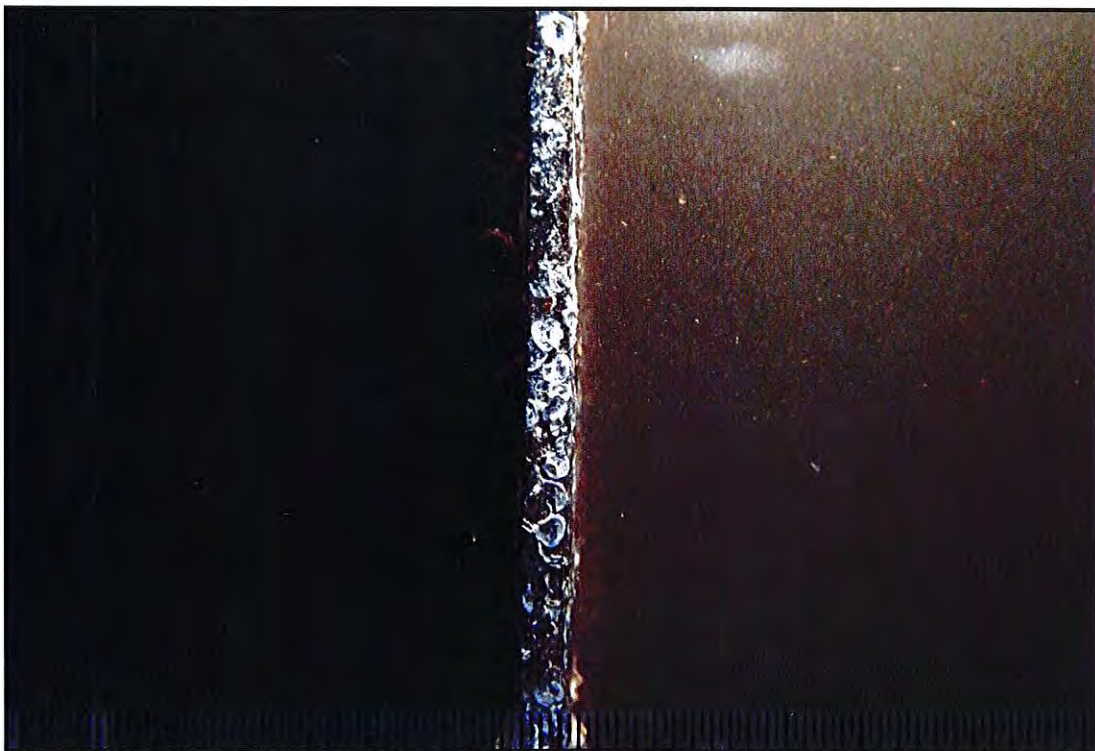
Photo B-20: Typical condition of the flange edge of a H-pile graded Major. H-pile location is the center-west H-pile of the pile cluster at Bent L and Pile Row 19.

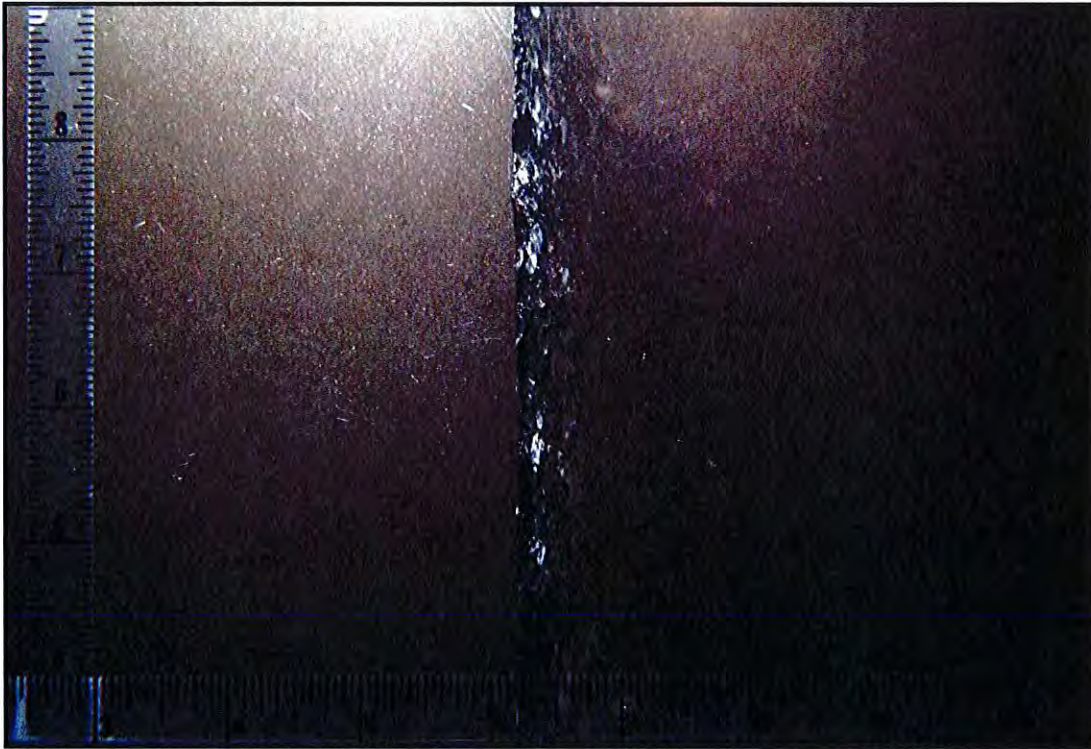
Photo B-21: Typical condition of the flange edge of a H-pile graded Severe. H-pile location at Bent K-bar and Pile Row 16-bar South.

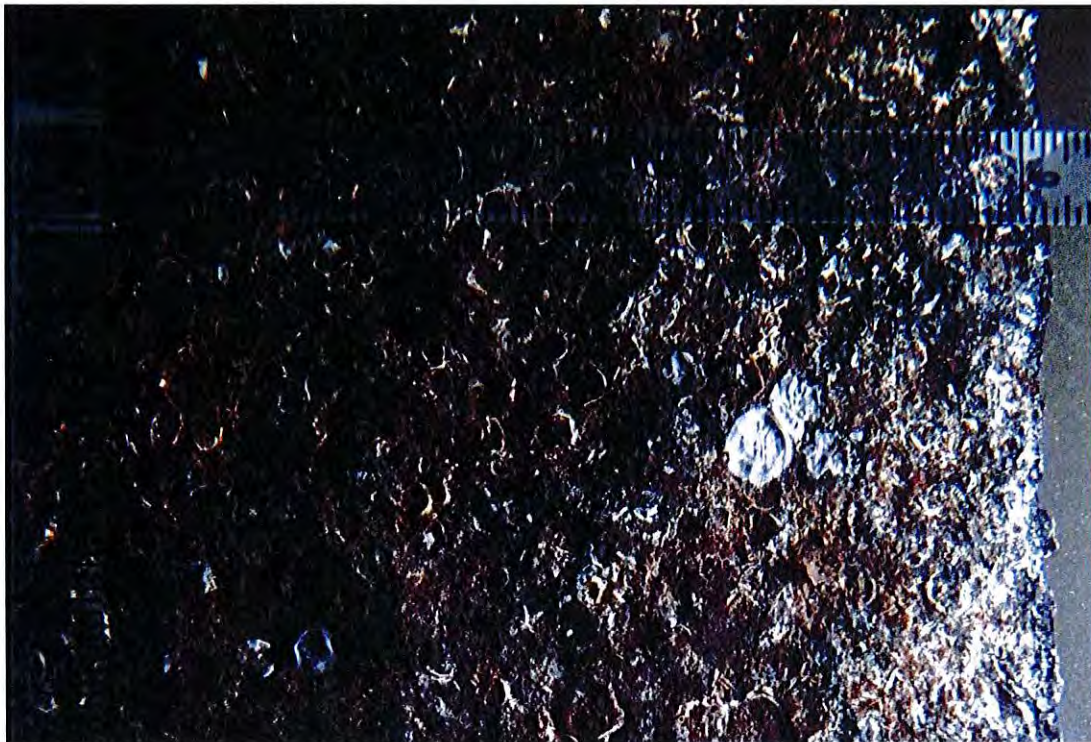
Photo B-22: Typical condition of the flange face of a H-pile graded Severe. H-pile location at Bent K-bar and Pile Row 16-bar South.

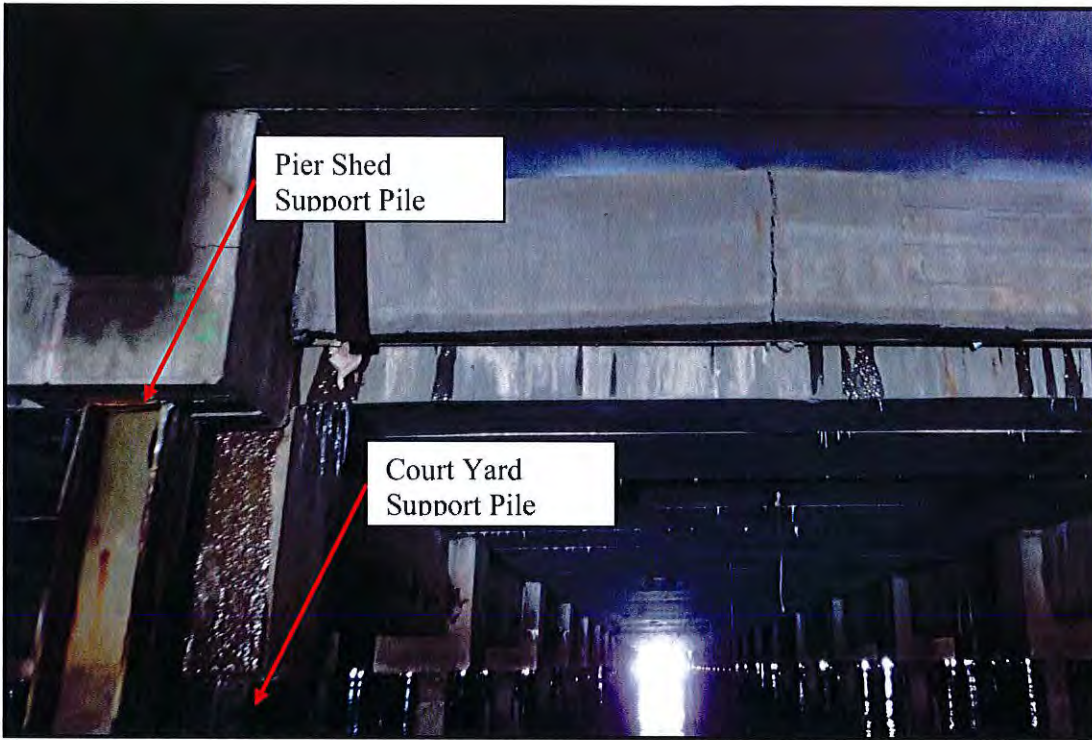
Photo B-23: Interface between Pier Shed and Court Yard. Note the difference in exposed pile length.

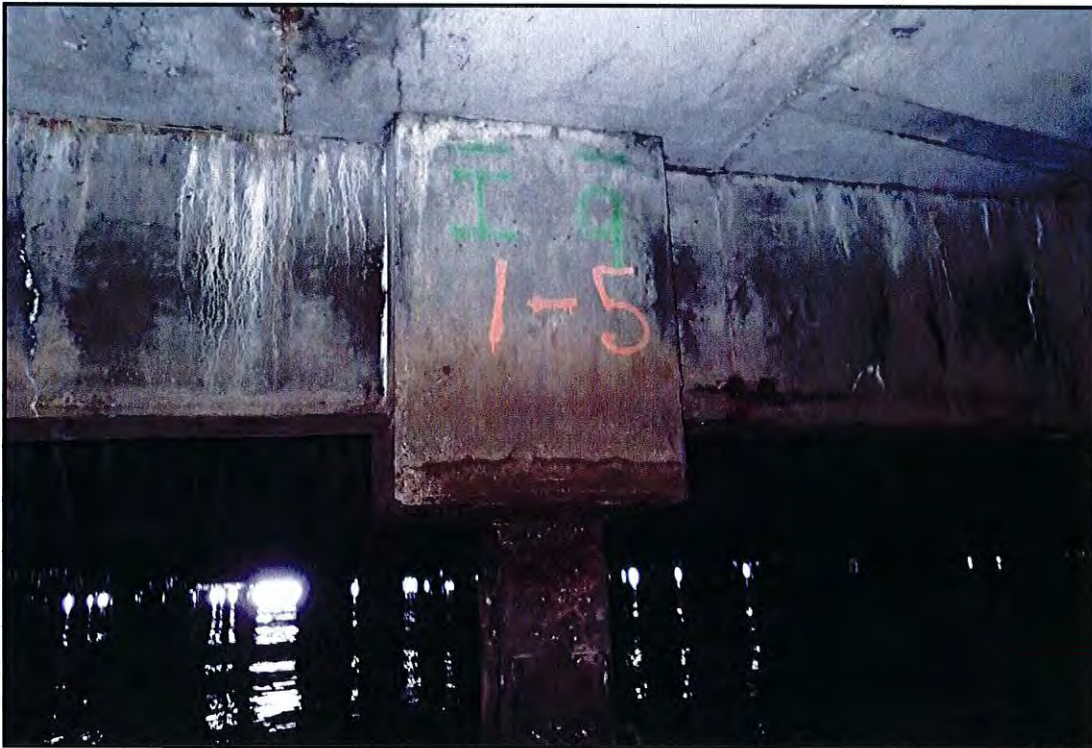
Photo B-24: Typical condition of concrete pile cap in the Court Yard. View looking west at Bent 1-bar, Pile Row 9-bar.

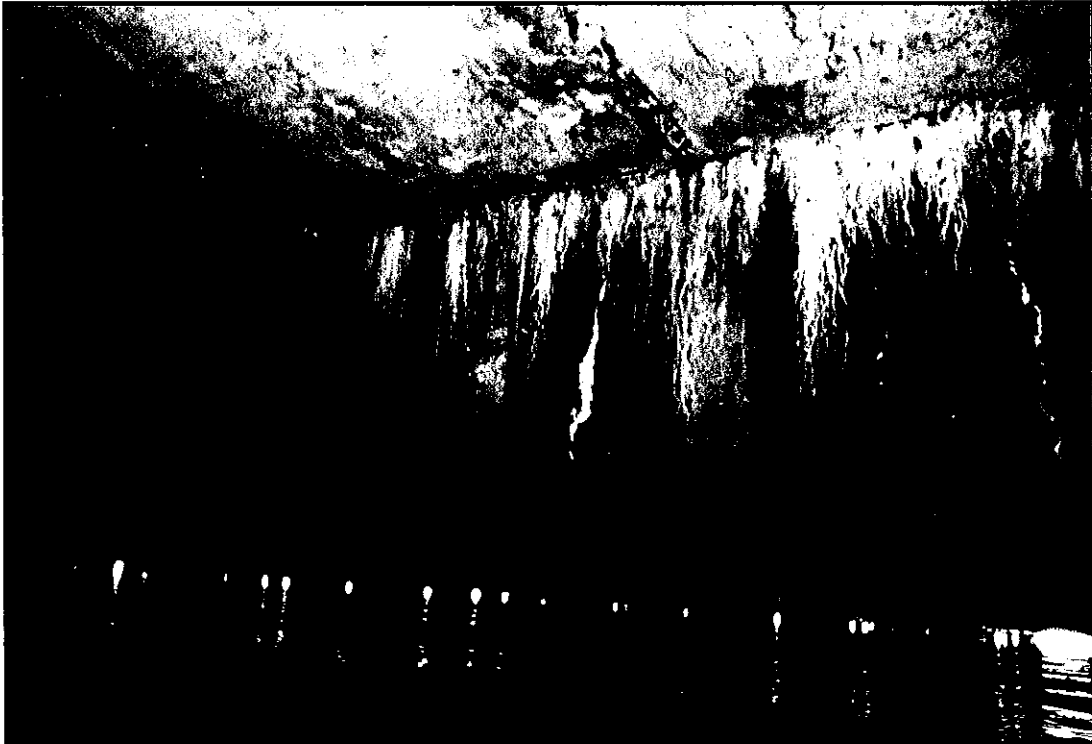
Photo B-25: Typical condition of concrete beam in the Court Yard with efflorescence and light cracking. View looking west at Bent I-bar, between Pile Row 9 and 9-bar.

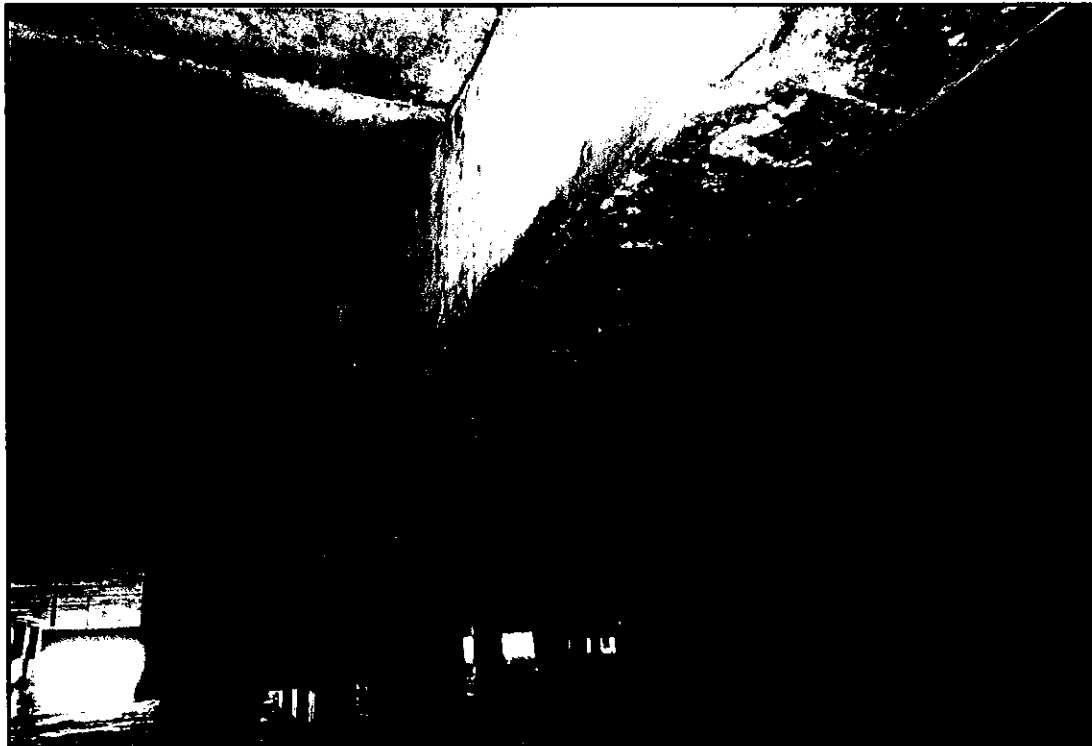
Photo B-26: Typical condition of concrete beam in the Pier Shed with light cracking and light rust staining. View looking north at Bent C, between Pile Row 17 and 17.3.

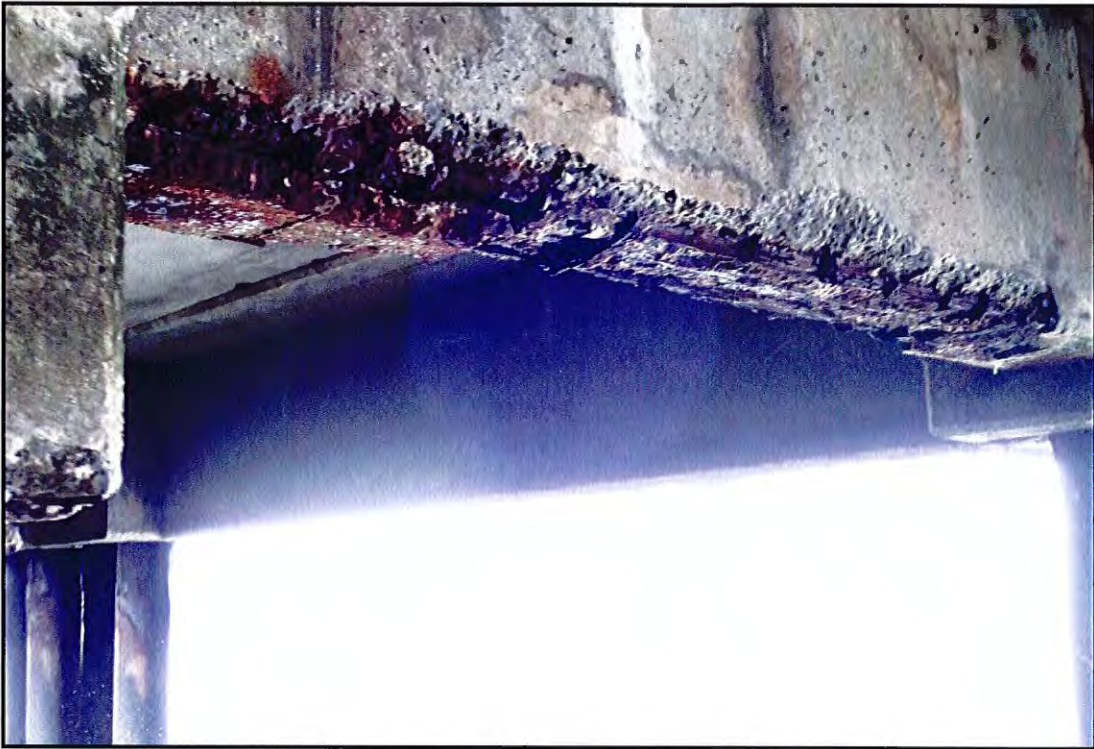
Photo B-27: Concrete beam in the Pier Shed with a full length spall and exposed reinforcement.
View looking west at Bent T.5 and Pile Row 8-bar.

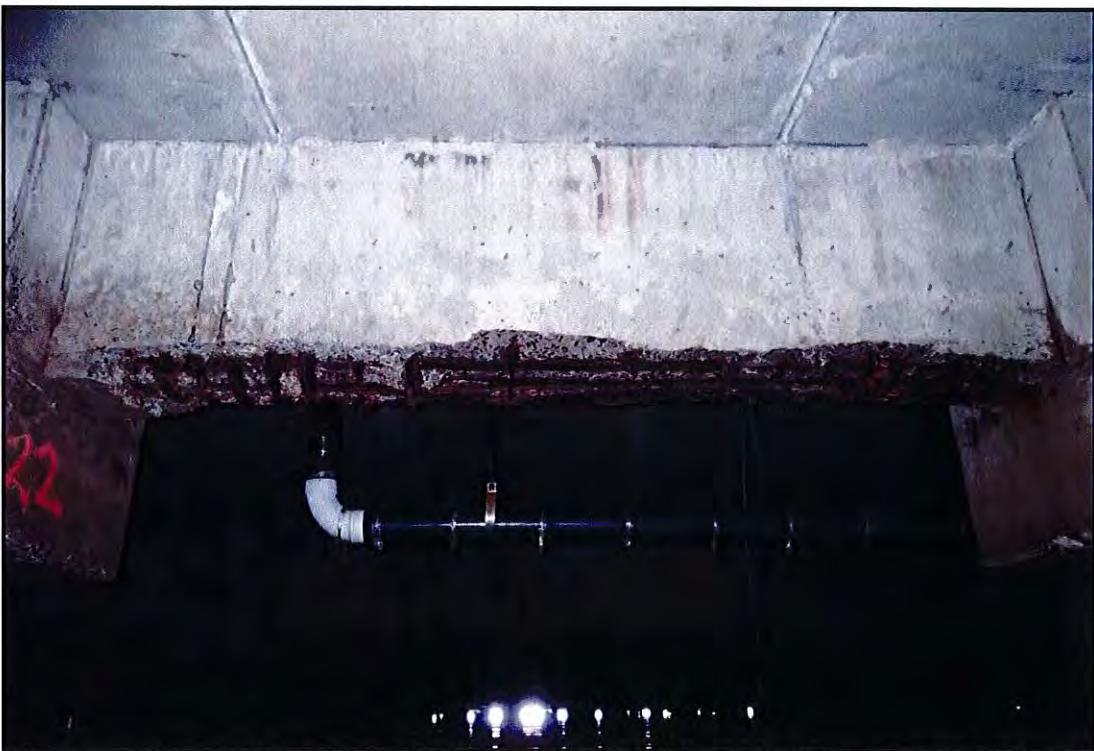
Photo B-28: Concrete beam in the Pier Shed with a full length spall and exposed reinforcement.
View looking west at Bent D-bar between Pile Row 8.5 and 8-bar.

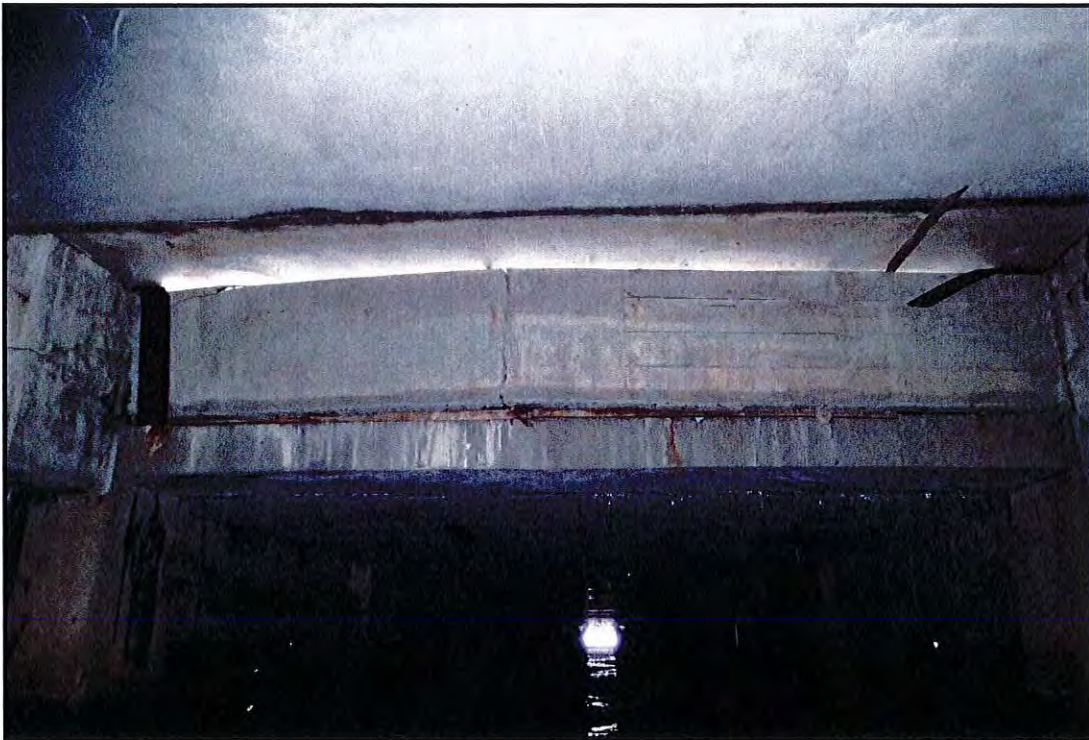
Photo B-29: Concrete closure wall with large vertical crack and deflection View looking north at Pile Row 7-bar between Bent I and I-bar.

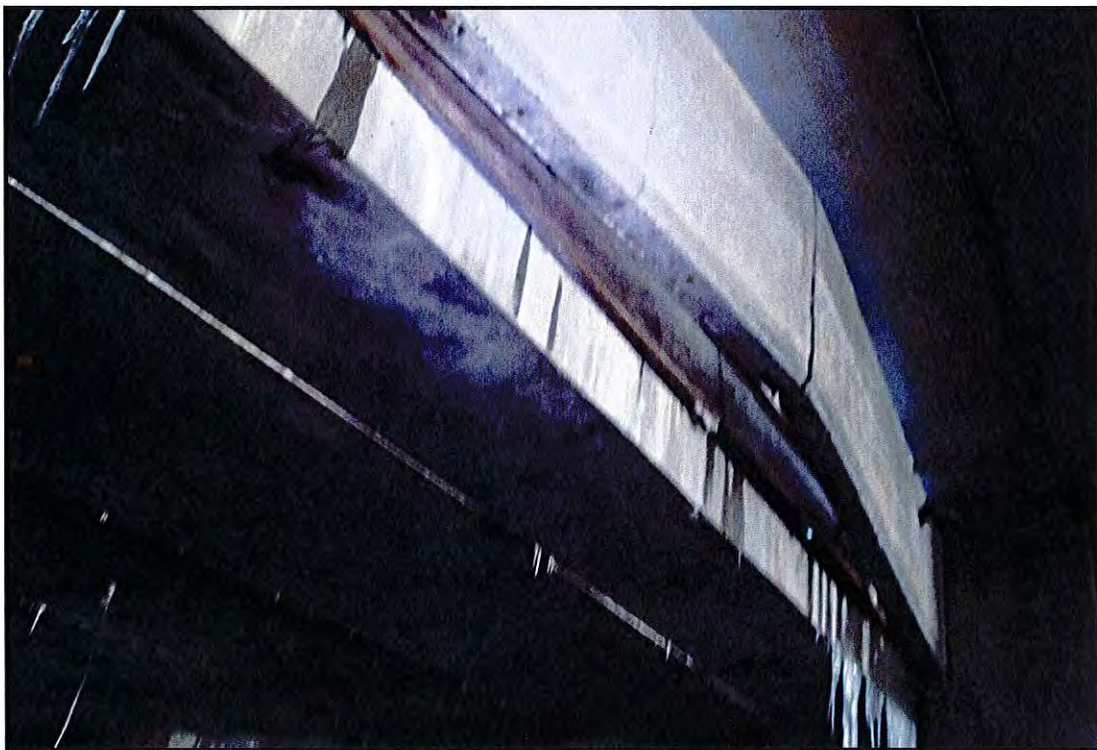
Photo B-30: Concrete closure wall with large vertical crack and deflection View looking east at Pile Row 7-bar between Bent I and I-bar.

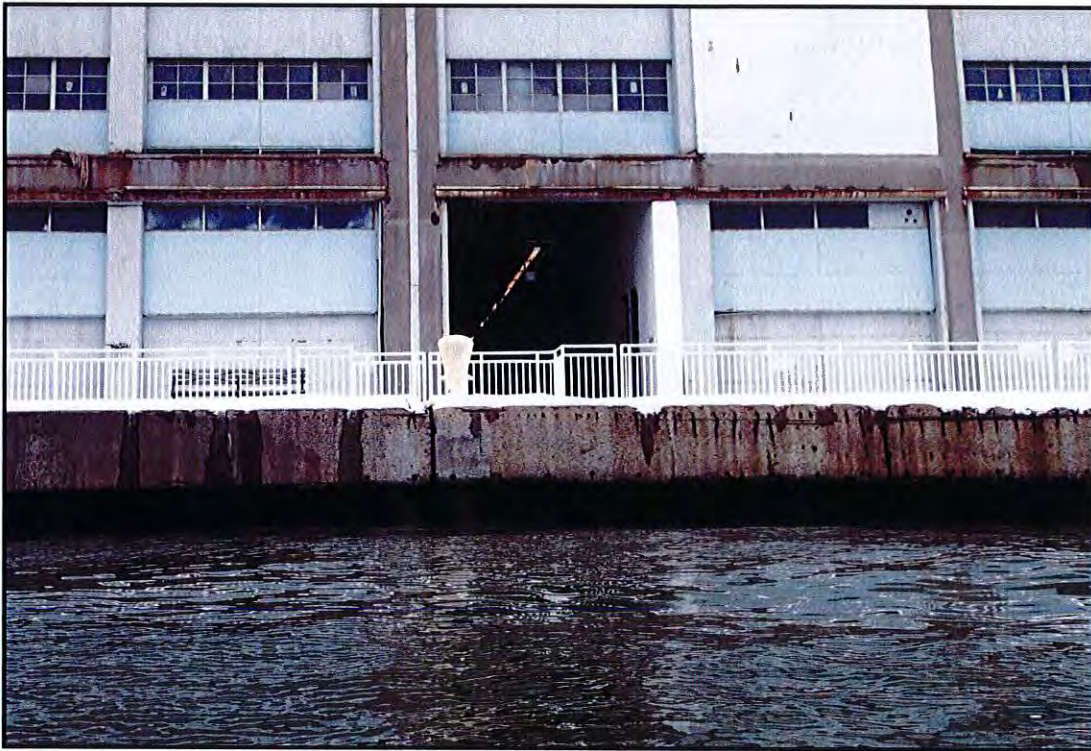
Photo B-31: Erosion up to 1 in. deep and exposed reinforcing along the full height of the western edge beam between Pile Rows 7 and 8-bar.

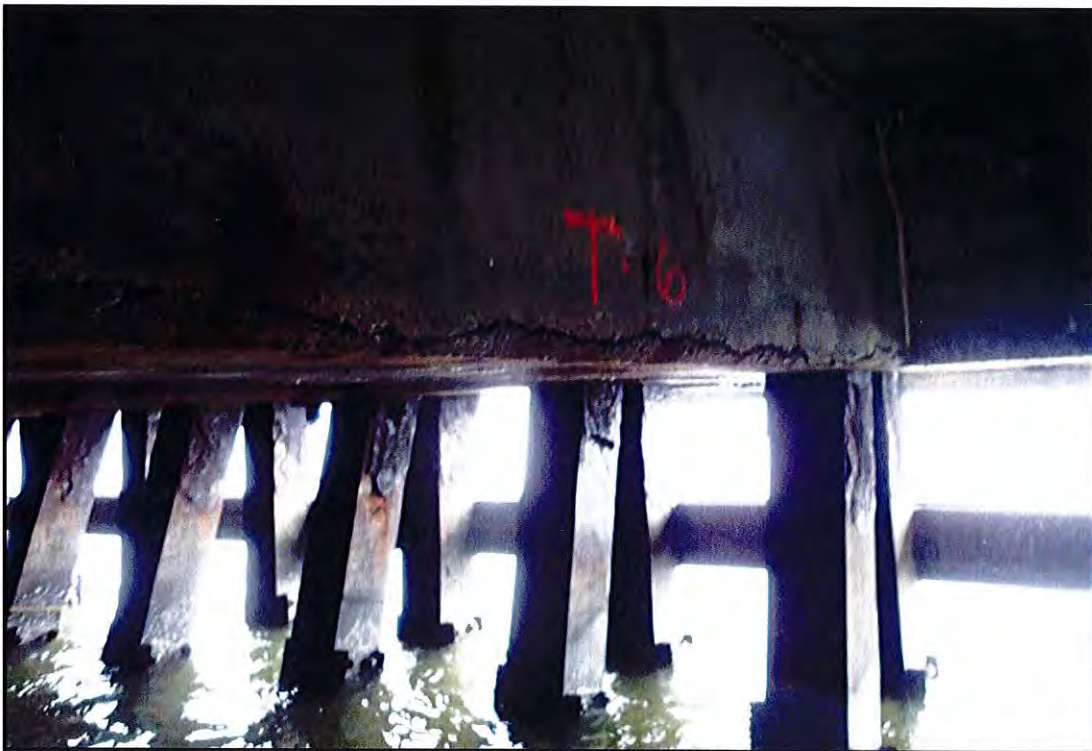
Photo B-32: Rust staining and delamination of the soffit of the first transverse beam north of Bent W at the Finger Pier Extension.

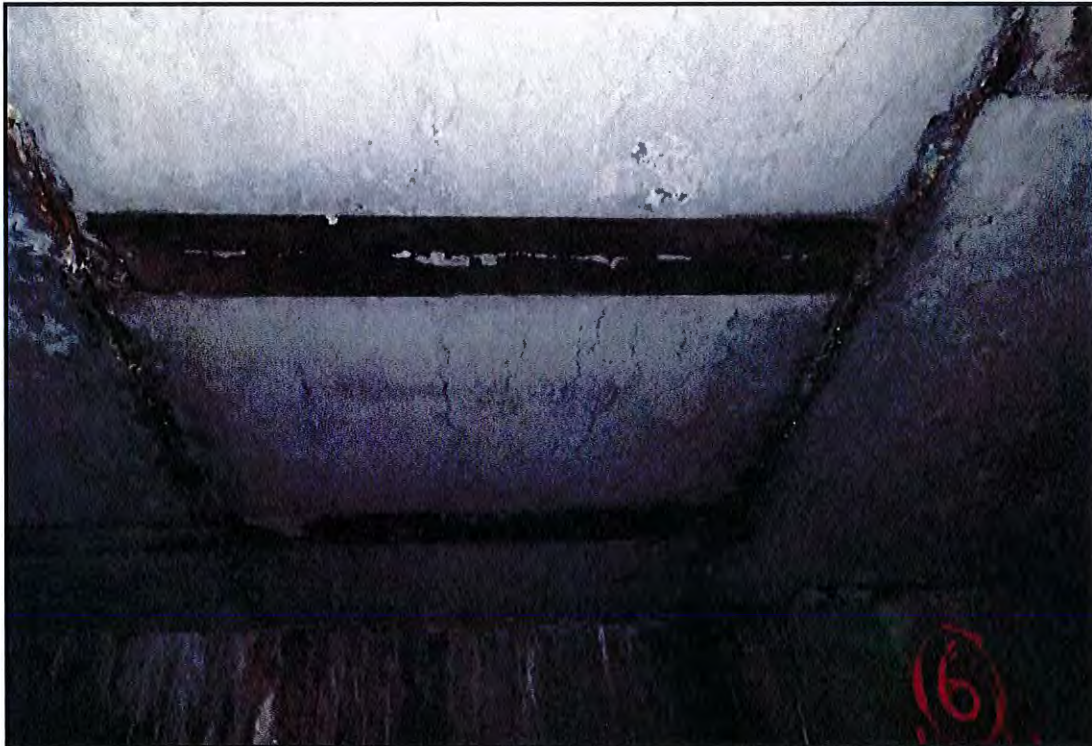
Photo B-33: Typical condition of Court Yard deck soffit with light shrinkage cracks. View looking west between Bent I and I-bar at Pile Row 9-bar.

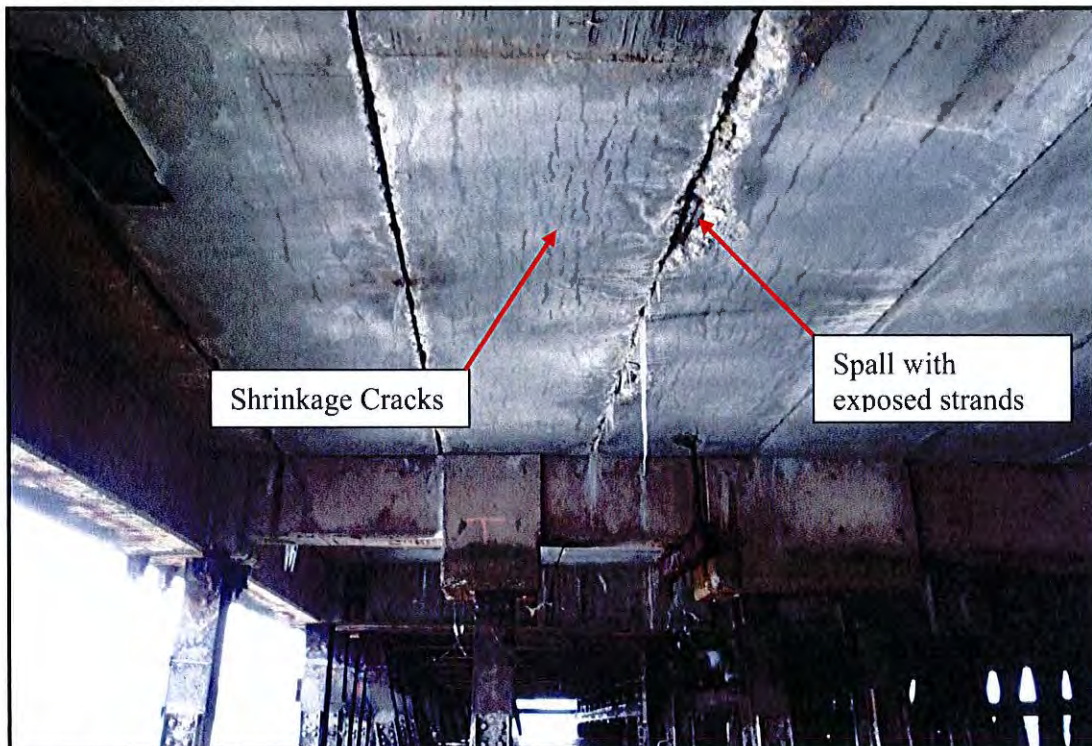
Photo B-34: Typical condition of Pier Shed deck soffit with light efflorescence and light shrinkage cracks. Also note the spall in the deck plank with exposed strands.

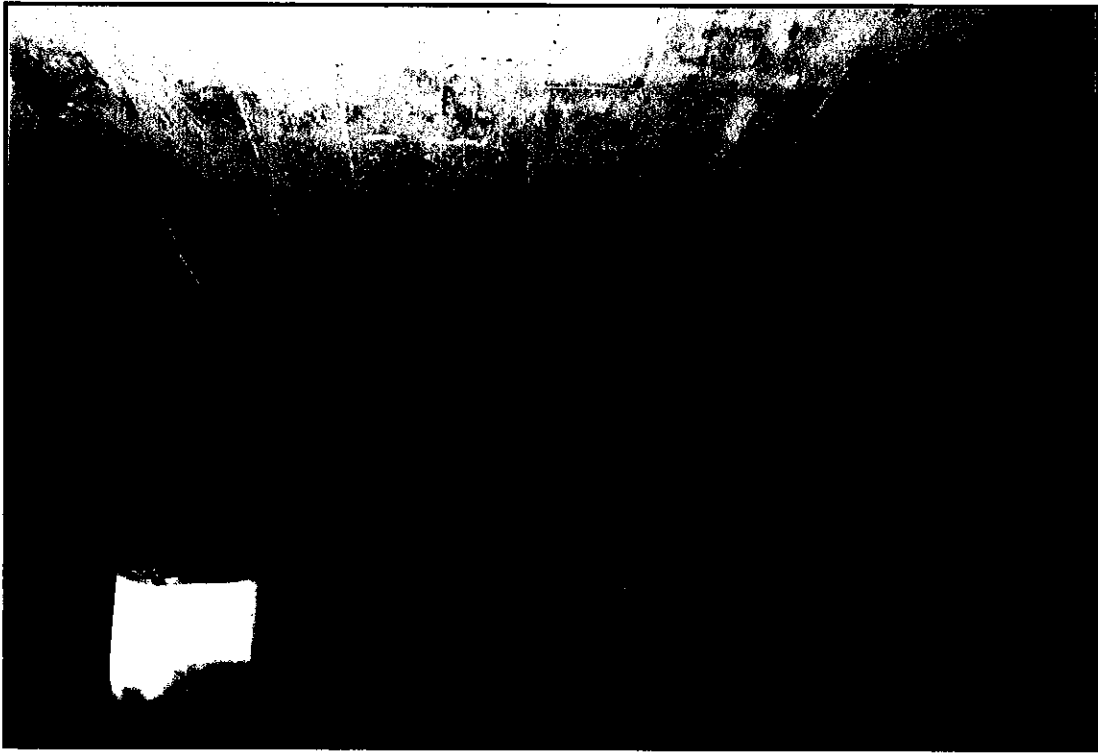
Photo B-35: Large spall at Pier Shed deck soffit with exposed reinforcement. View looking north between Bents A and B at Pile Row 3.

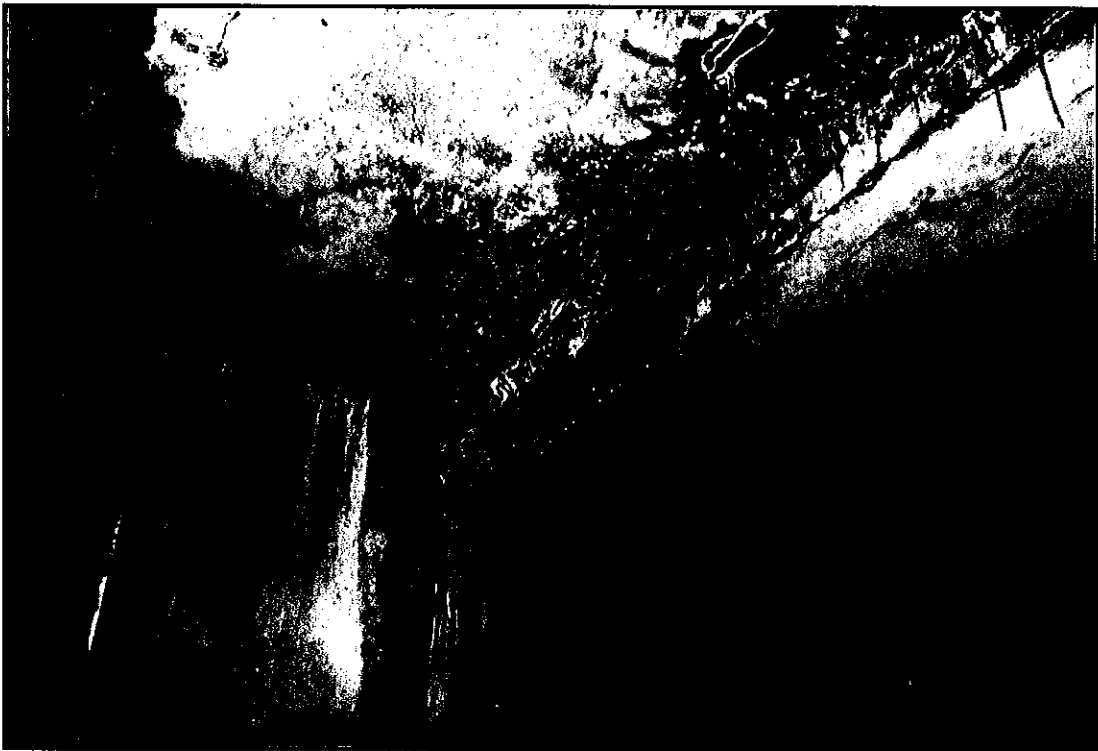
Photo B-36: Precast deck plank located east of Pile 9 in Bent F with multiple exposed and broken prestressed strands.

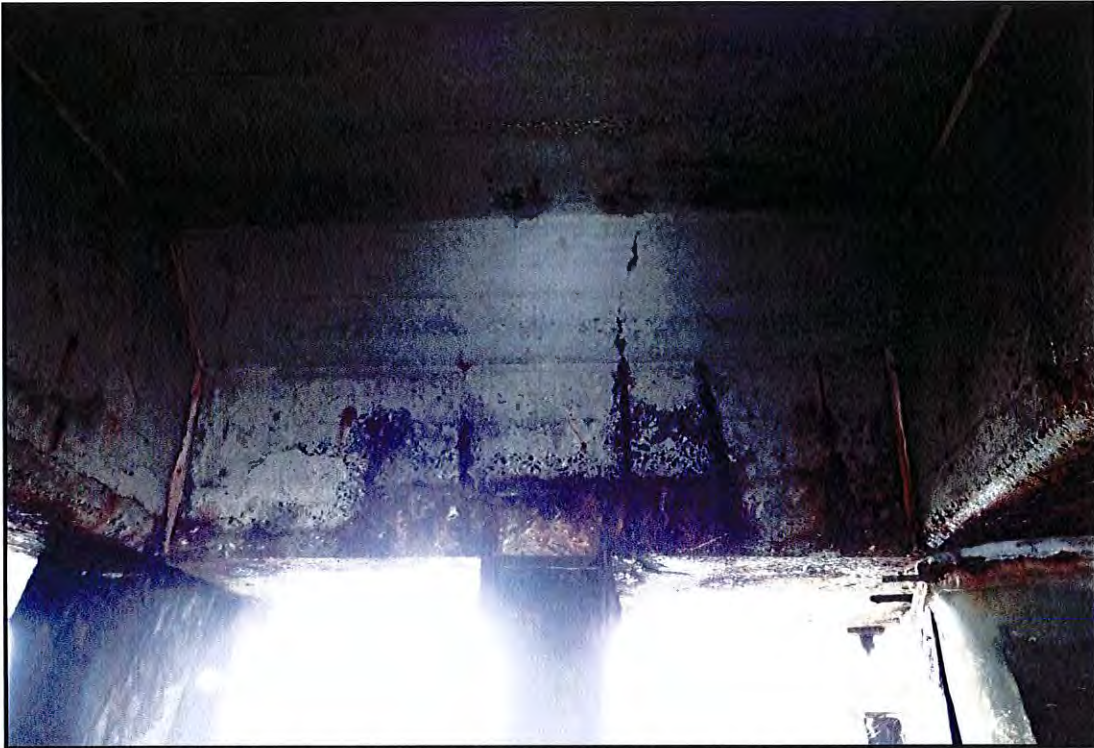
Photo B-37: Spall along the north cap of the Finger Pier Extension between Bent Z and Bent Z.2. View looking north.
