APPENDIX B
PHOTOGRAPHS

Photo B-1: Overall view of Pier 40, looking southeast.

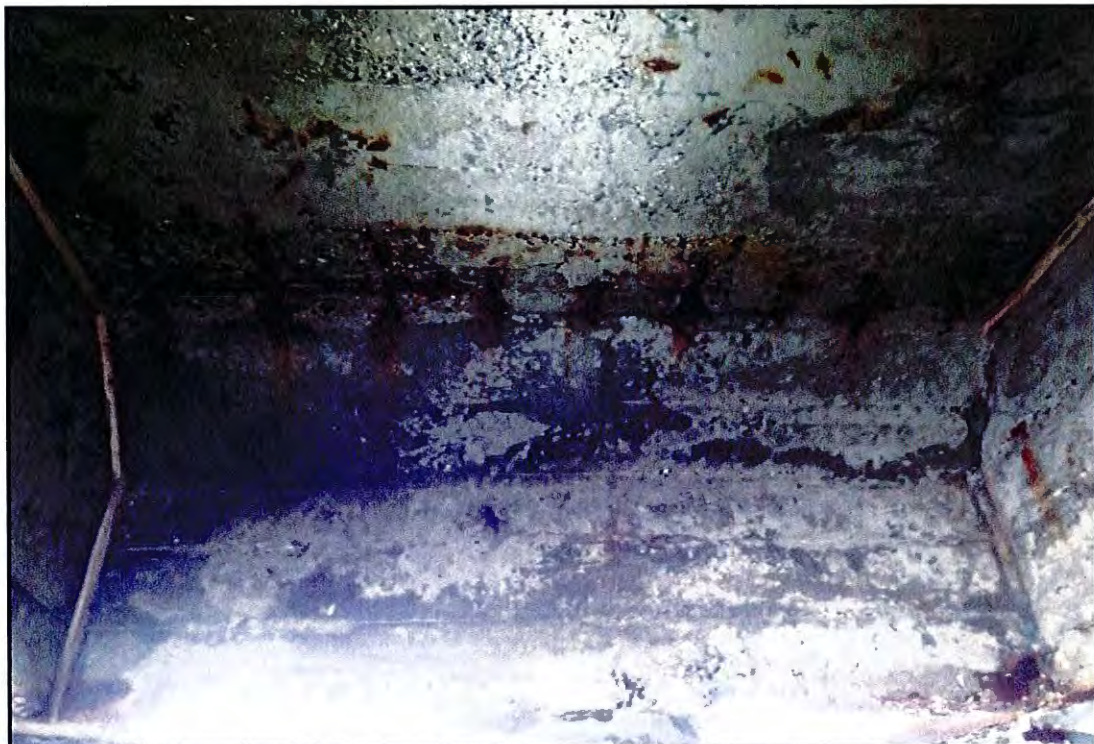
Photo B-38: Spall along the deck soffit of the Finger Pier Extension between Bent X.7 and Bent Y adjacent to the north cap. View looking north.

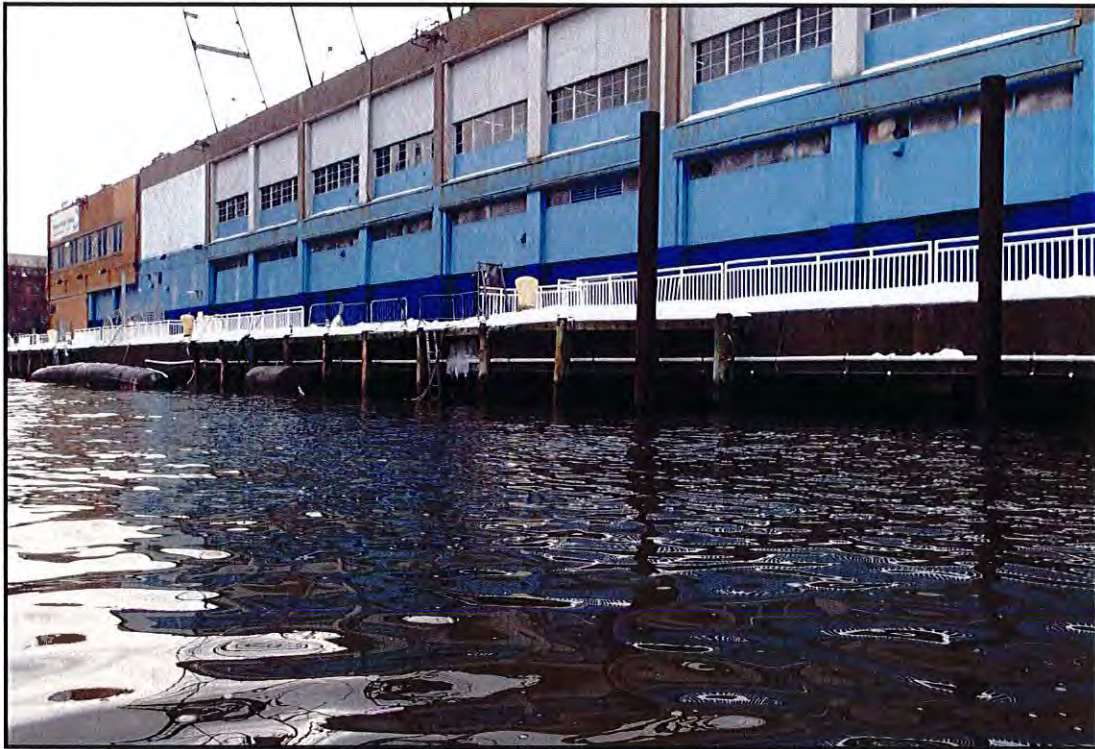
Photo B-39: Fender system along the north side of the Pier. Note the two steel fender piles located north of the timber fender system.

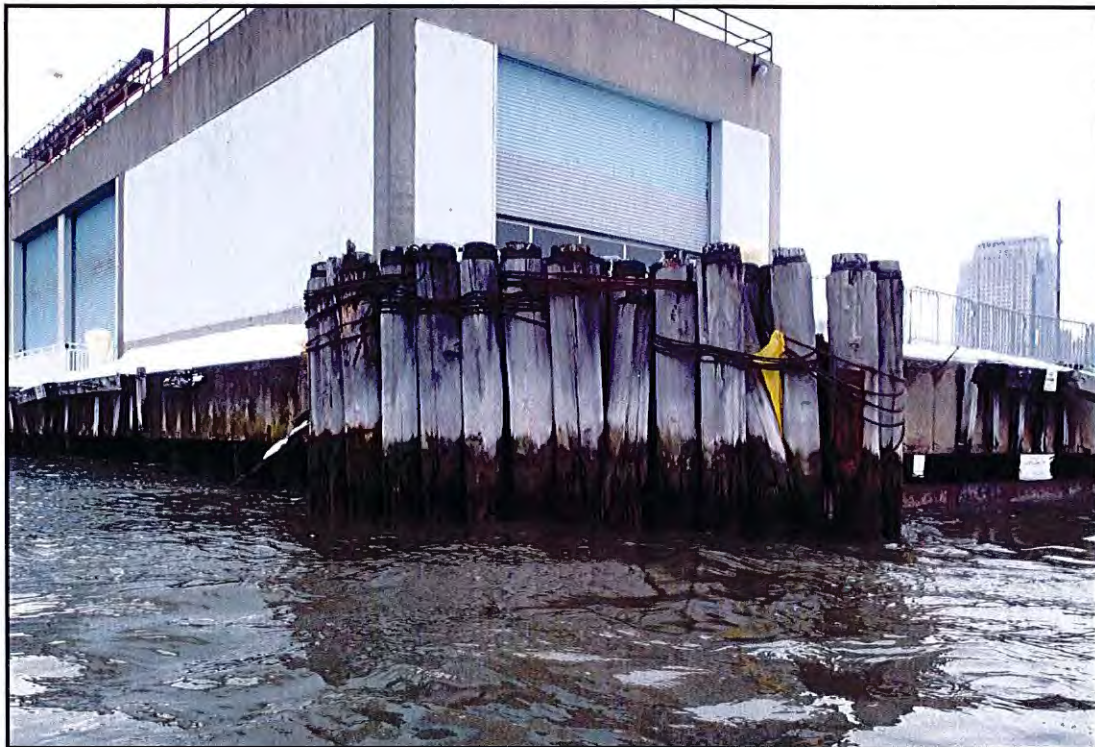
Photo B-40: Pile cluster at the north corner of the Finger Pier Extension. Note the severe damage at the MLW elevation and the loose wire rope wraps at the top of the cluster.

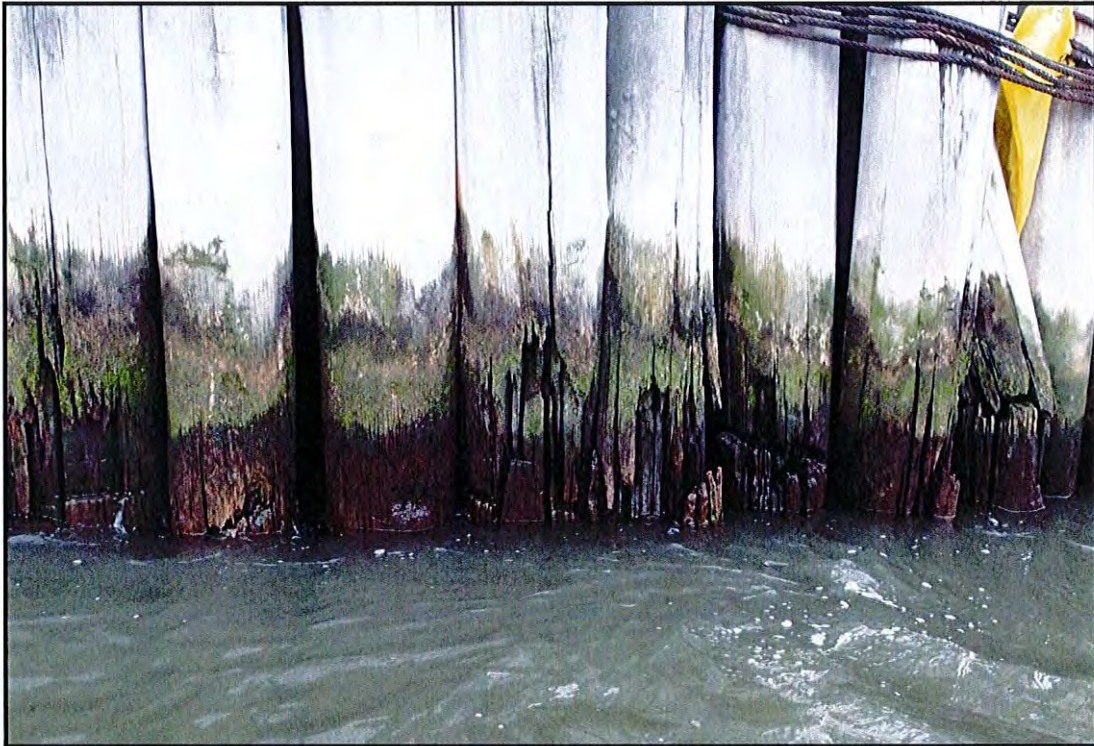
Photo B-41: Close-up of broken piles in the fender pile cluster at the north corner of the Finger Pier Extension.
