Hudson River Park Trust

PARKWIDE MARINE INSPECTION, ENGINEERING, DESIGN, CONSTRUCTION & ADMINISTRATION SERVICES
CONTRACT No. A3056 - PHASE 47

CONDITION MONITORING INSPECTION

PIER 40

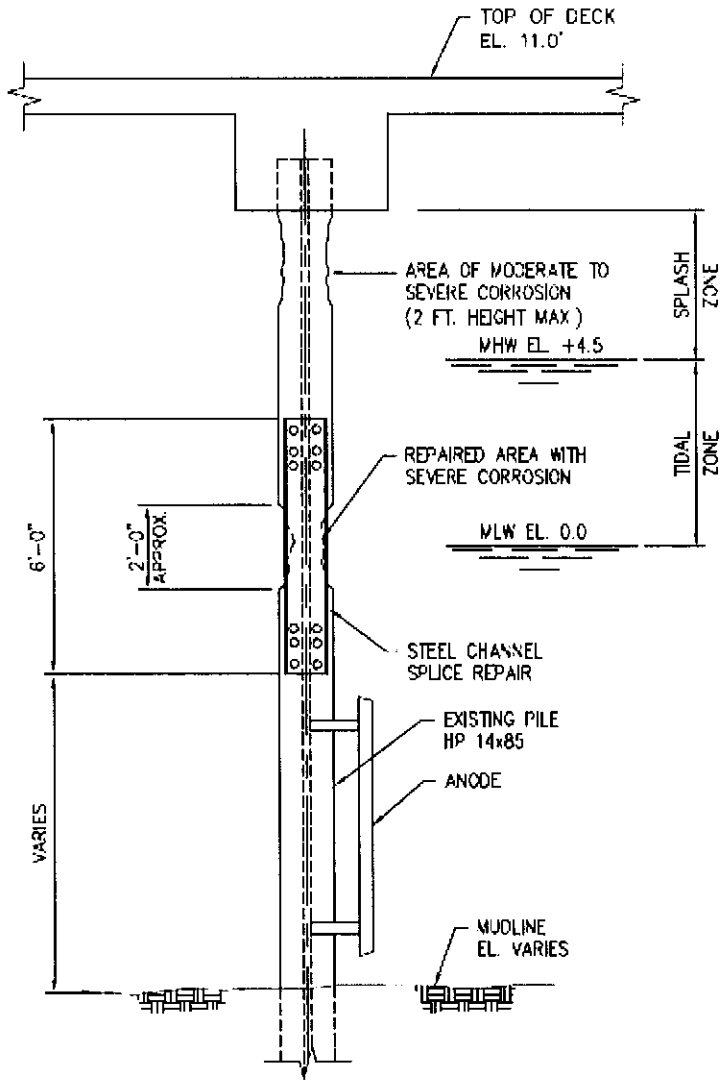
TYPICAL CHANNEL REPAIRS

A total of four types of repairs were implemented on the steel H-piles at Pier 40 during two repair phases in the late 1980s. Of these repair types, three are located at the tops of the H-piles and one is located at MLW. At the tops of the H-piles, either a protective epoxy coating, welded steel plates with a protective epoxy coating (steel plate and epoxy repair), or concrete jackets (encasement repair) were installed (Photos B-9 and B-10). These repairs were installed to protect or structurally reinforce the H-piles within the splash zone, which is where a typical zone of severe corrosion is located. The repair at MLW, consisting of C12x30 or MC12x35 channels with 12 or 20 bolts, respectively, functions to span a typical zone of severe corrosion at the MLW elevation and structurally connect the H-pile pile sections above and below the corrosion (channel repair) (Photo B-11 and 12).

Nearly all H-piles have at least one sacrificial anode installed. A typical elevation view of a pile with a channel repair is shown on Figure 2-1.

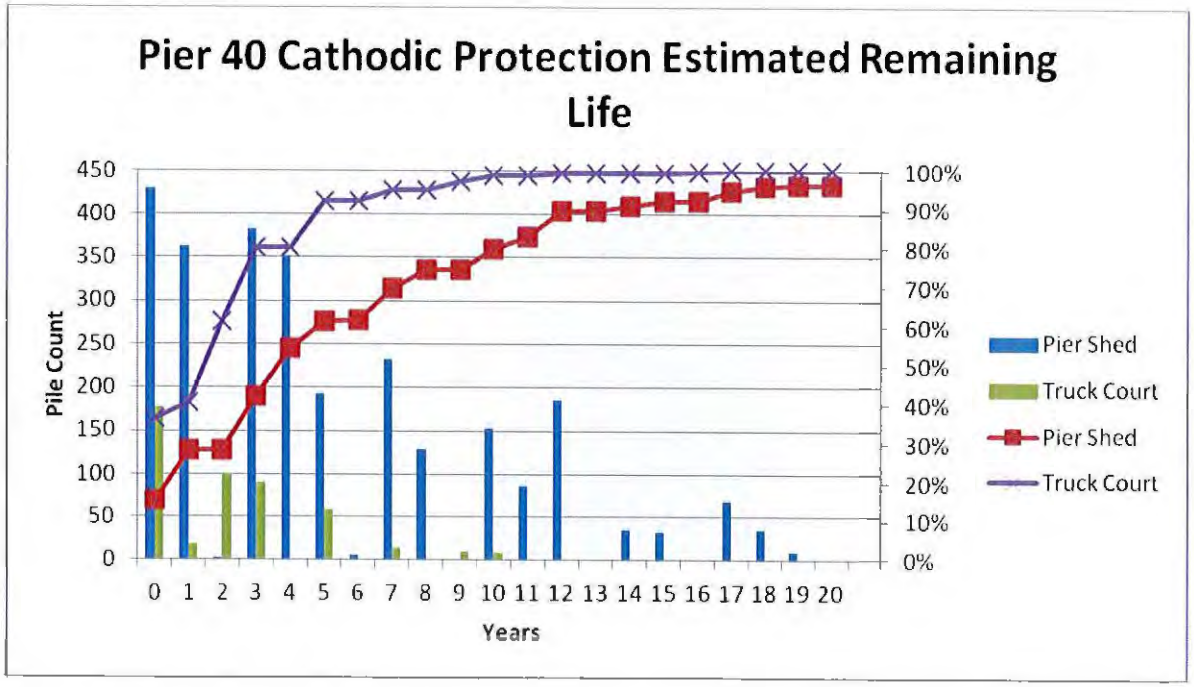
The Court Yard H-piles are typically protected by two anodes per pile. The remaining useful life of these anodes ranges between 0 years and 17 years, with a median remaining useful life of 1 year. The Pier Shed H-piles are protected by two to five anodes per pile. The remaining useful life of these anodes ranges between 0 years and more than 20 years, with a median remaining useful life of 3.5 years. The graph below illustrates the information provided in the table above.

As illustrated in the graph above, a steep increase in the number of unprotected H-piles is expected over the next 3 years under the Court Yard. The Pier Shed is expected to experience a steady increase in unprotected H-piles over the next 10 years.

Overall, the electrical potential readings presented in Table 3-5 suggest that all H-piles are currently protected by the existing cathodic protection system; however, the estimated remaining life calculations suggest that the sacrificial anode system is nearing the end of its useful life, and is possibly no longer adequately protecting the H-piles in many areas. The following is a list of items that were considered when developing recommendations for the cathodic protection system.

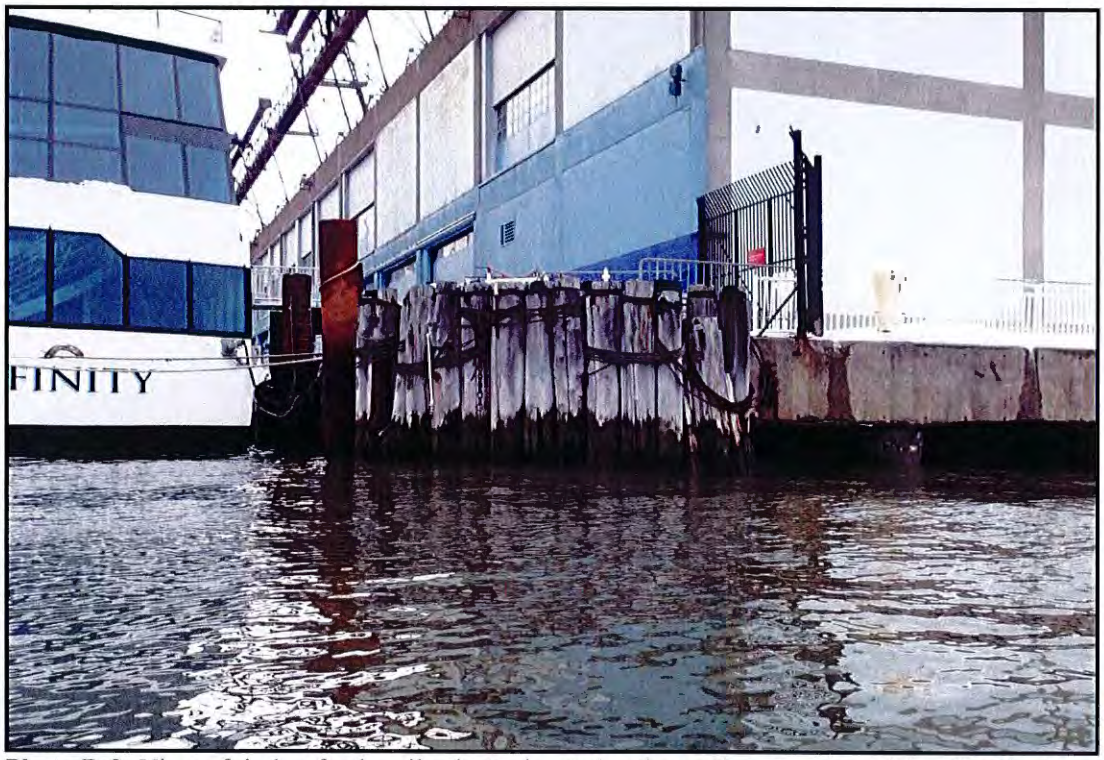
Photo B-8: View of timber fender pile cluster located at the northwest corner of the Pier Shed. Note steel fender piles with full coverage coating loss.

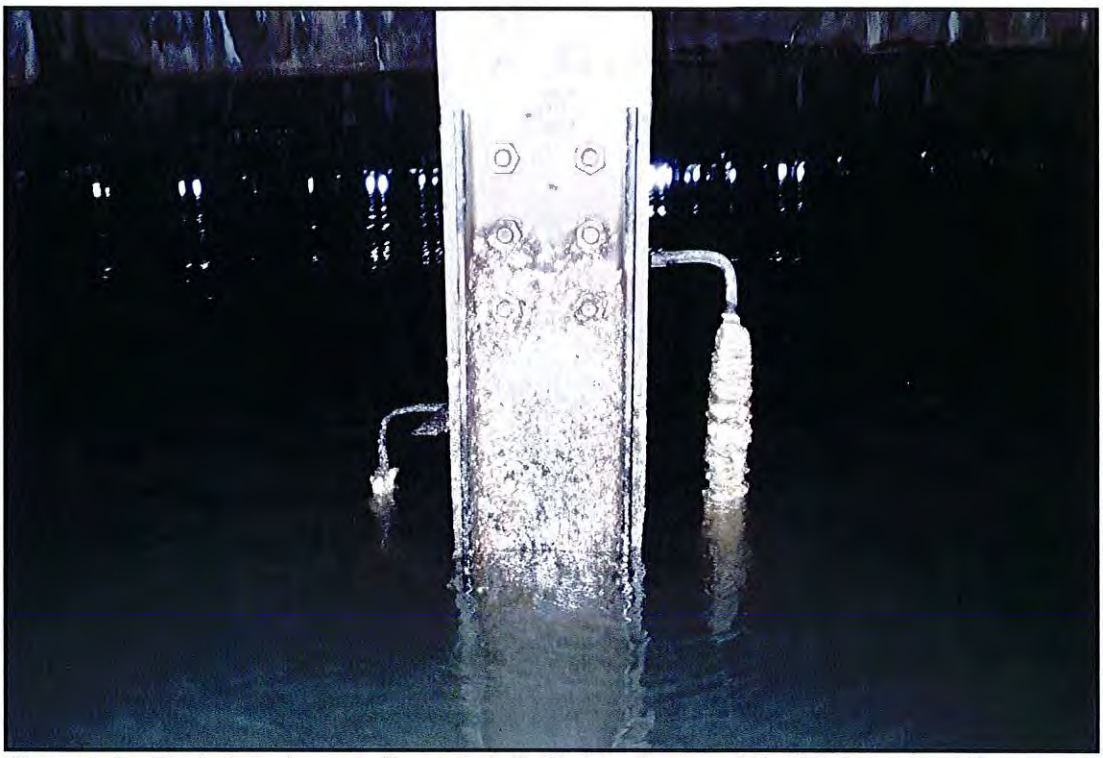
Photo B-11: Typical C-channel pile repair bolted to the flanges of H-pile I-bar 9-bar, view looking west. Note the depleted anodes attached to each side of the H-pile.

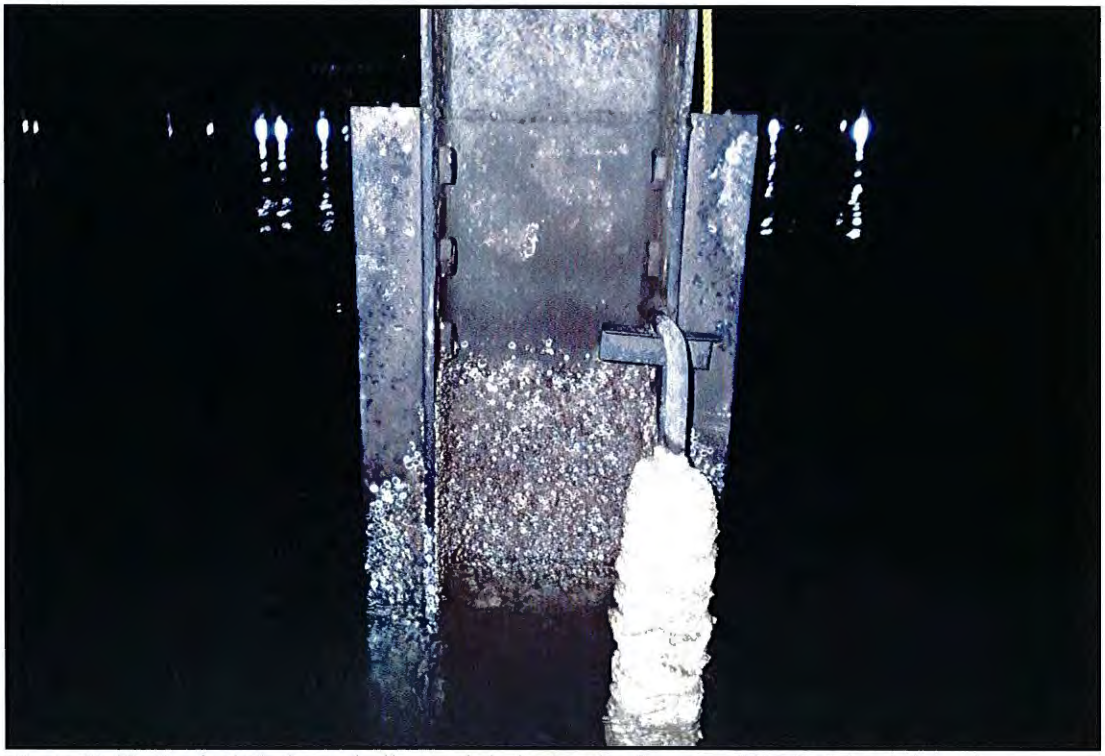
Photo B-12: Typical C-channel pile repair bolted to the flanges of H-pile I-bar 9-bar, view looking south.

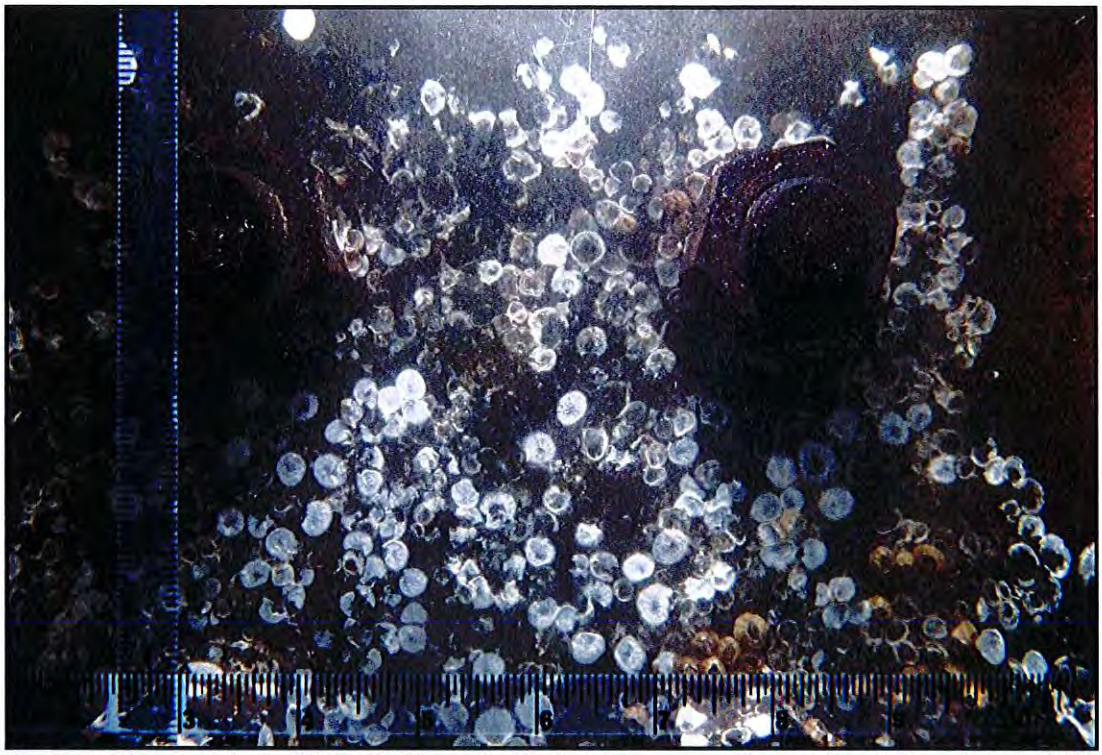
Photo B-13: Typical condition of bolts at the C-channel repairs. Photo at H-pile location T 18.75 in the Pier Shed.

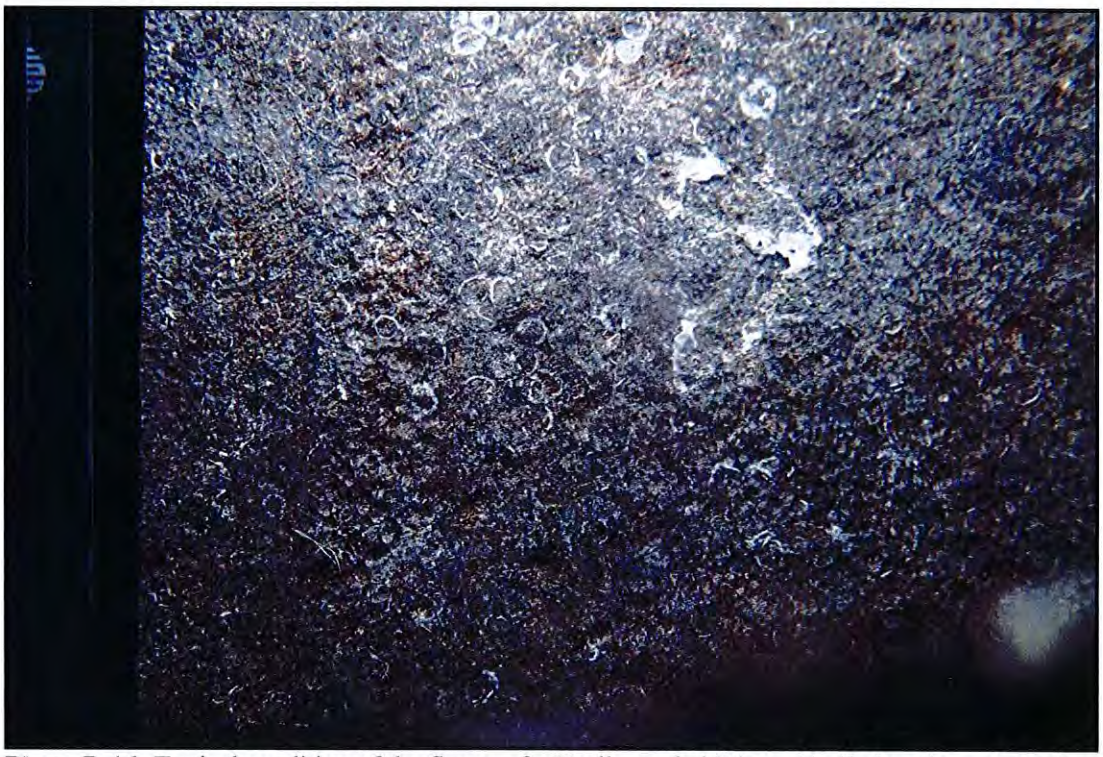
Photo B-16: Typical condition of the flange of a H-pile graded Minor. H-pile location at Bent S-bar and Pile Row 19.

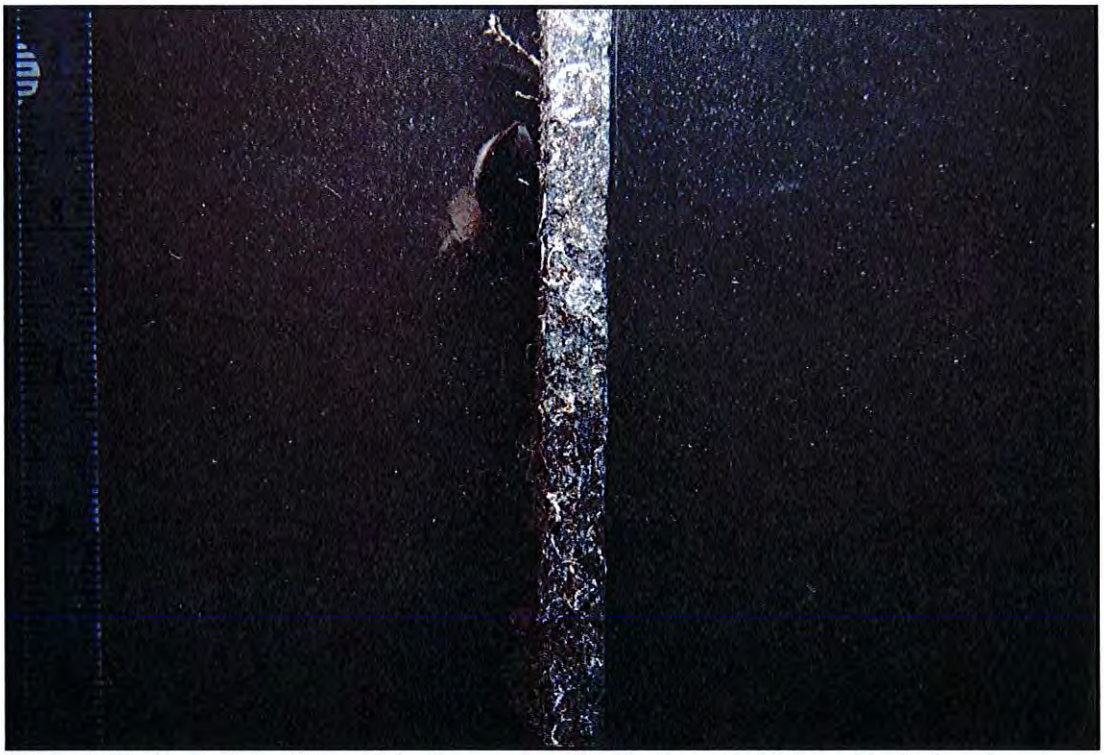
Photo B-17: Typical condition of the flange edge of a H-pile graded Minor. H-pile location at Bent S-bar and Pile Row 19.

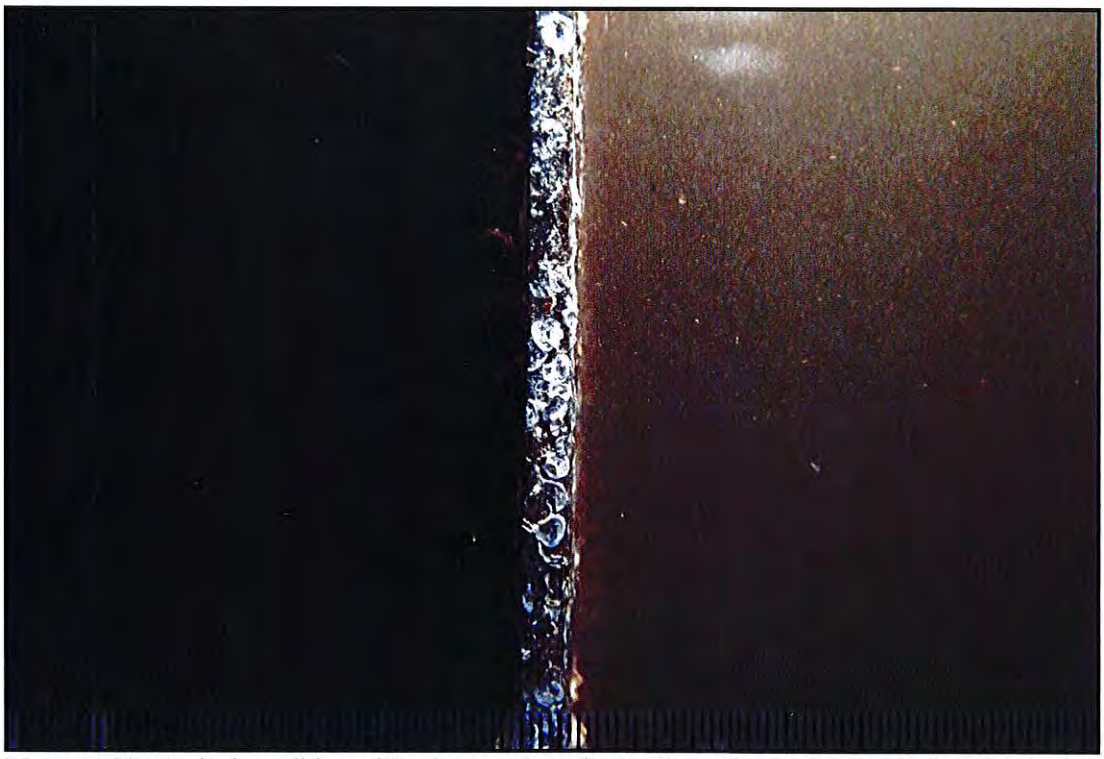
Photo B-20: Typical condition of the flange edge of a H-pile graded Major. H-pile location is the center-west H-pile of the pile cluster at Bent L and Pile Row 19.

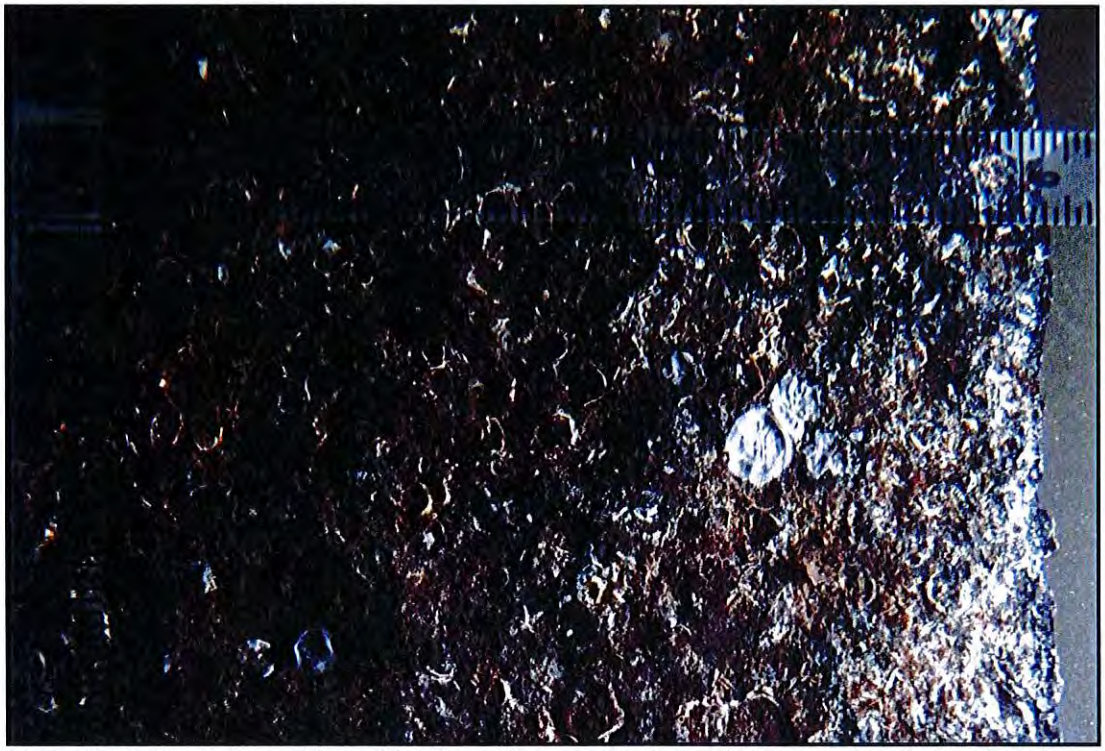
Photo B-22: Typical condition of the flange face of a H-pile graded Severe. H-pile location at Bent K-bar and Pile Row 16-bar South.

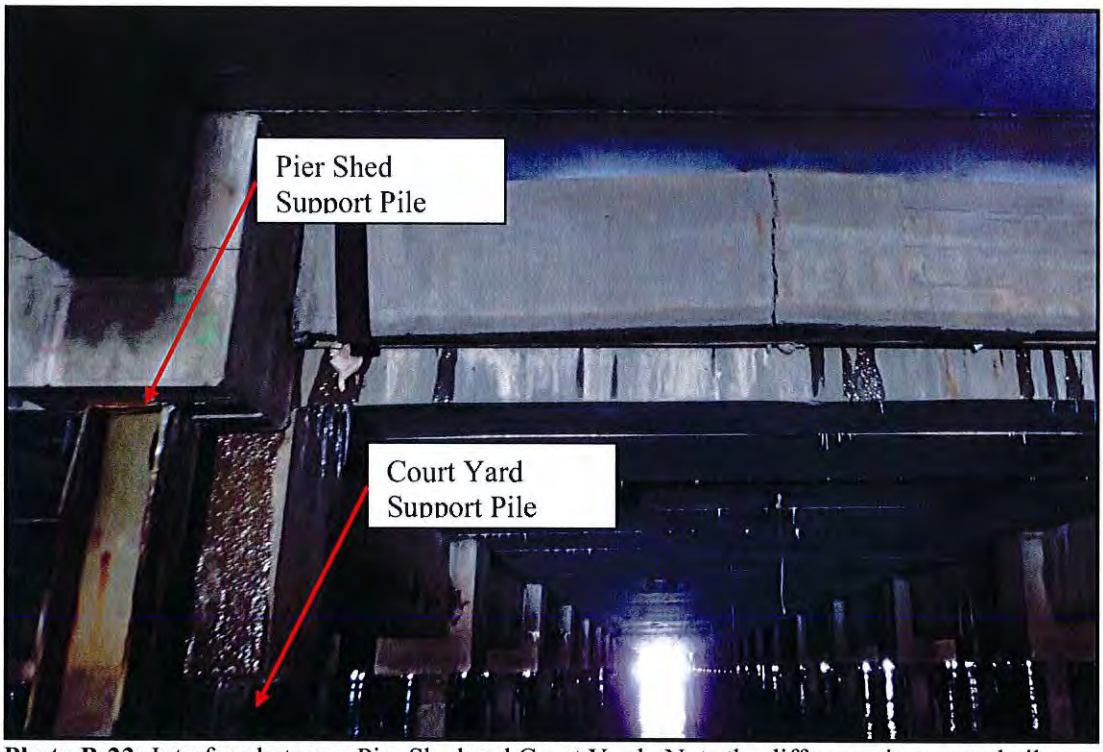
Photo B-23: Interface between Pier Shed and Court Yard. Note the difference in exposed pile length.

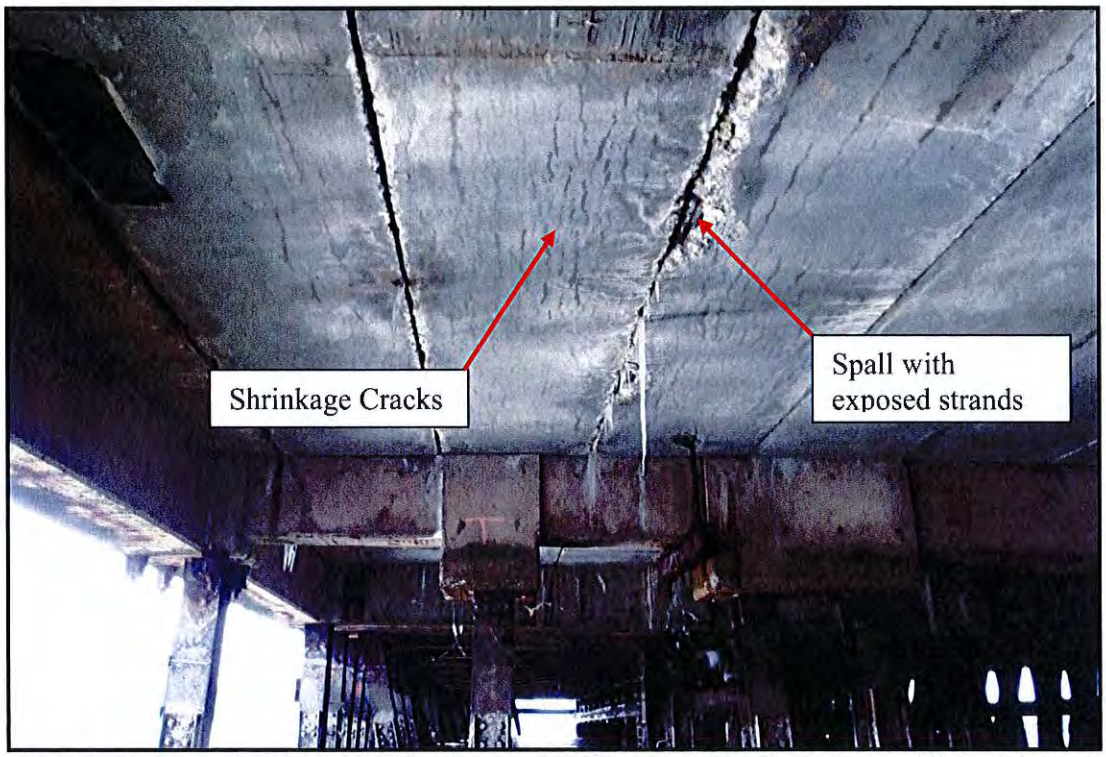
Photo B-34: Typical condition of Pier Shed deck soffit with light effloresense and light shrinkage cracks. Also note the spall in the deck plank with exposed strands.

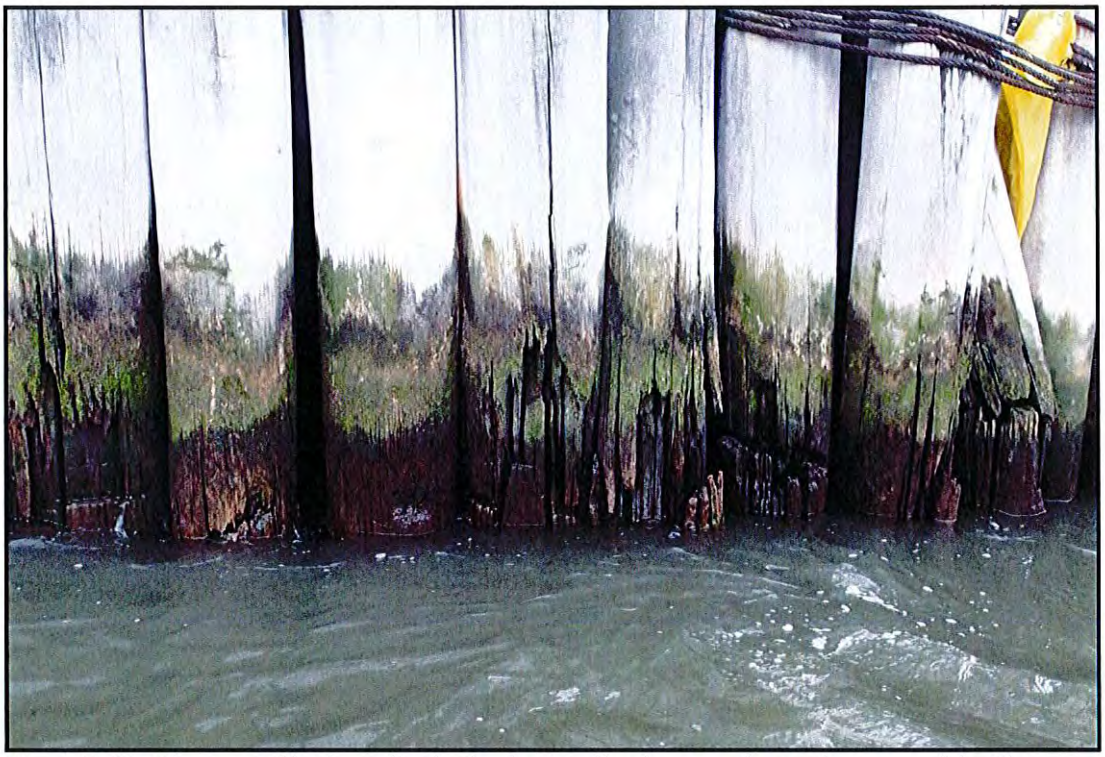
Photo B-41: Close-up of broken piles in the fender pile cluster at the north corner of the Finger Pier Extension.
